Access Compliance Report

Public Rights-of-Way

(Curb Ramps)

Intersection ID: 26384	Main Street: BEVINGTON_PL	Cross Street: ELM_LN	Location: SE
ADA ID: 0E039DBC995	Ramp Type: Perp	Initial Pass/Fail: Fail	Overall Compliance: No
		Severity Score: 37.5

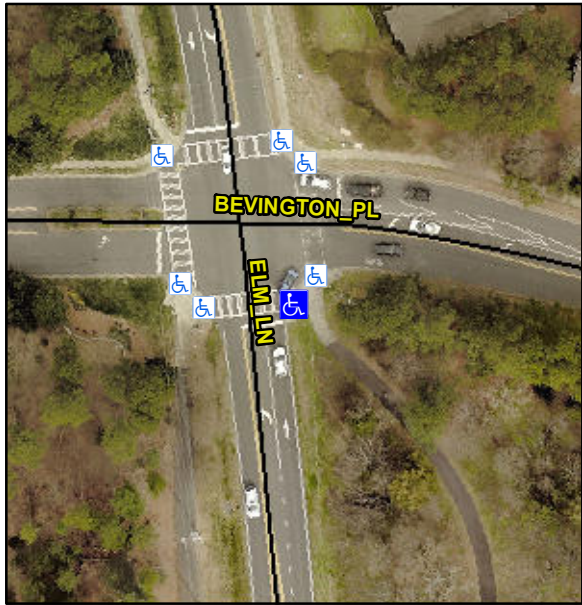
Possible Solutions:		Compliance			Description			Data	Compliance			Description			Data
	Remove & Replace Entire Ramp.		N/A	Ramp Length (in)			60.0			No	Ramp Slope (%)			12.1		
			Yes	Ramp Width (in)			57.0			No	Ramp XSlope (%)			6.2		
			N/A	Flare Type LT			N/A			N/A	Flare Type RT			N/A		
			N/A	Flare Slope LT (%)			N/A			N/A	Flare Slope RT (%)			N/A		
			N/A	Flare Traversable LT?			N/A			N/A	Flare Traversable RT?			N/A		
			N/A	Landing Length (in)			N/A			N/A	DWS Provided?			N/A		
			N/A	Landing Width (in)			N/A			N/A	DWS Contrast?			N/A		
			N/A	Landing Slope (%)			N/A			N/A	DWS Length (in)			N/A		
			N/A	Landing X Slope (%)			N/A			N/A	DWS Full Width?			N/A		
Surveyor Notes:		N/A	N/A			N/A			N/A	DWS Offset (in)			N/A			
PROW/ADA:		R304.2.2, R304.5.3	N/A			N/A			N/A	Gutter Slope (%)			N/A			
			N/A			N/A			N/A	Gutter X Slope (%)			N/A
