Access Compliance Report

Public Rights-of-Way

(Curb Ramps)

Intersection ID: 12887	Main Street: CRAIGWOOD_DR	Cross Street: HICKORY_GROVE_RD	Location: NW
ADA ID: 0E1403C7E153	Ramp Type: Perp	Initial Pass/Fail: Fail	Overall Compliance: No
		Severity Score: 12.5

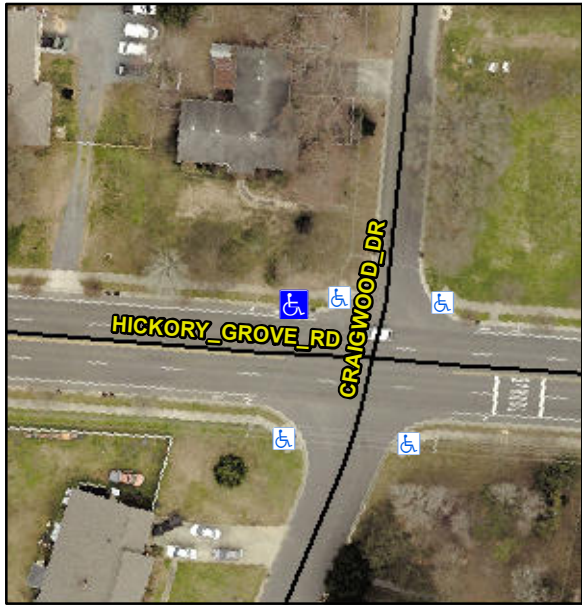
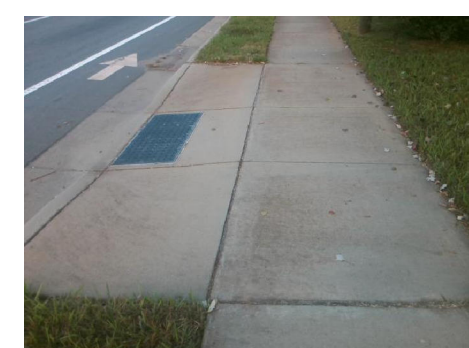
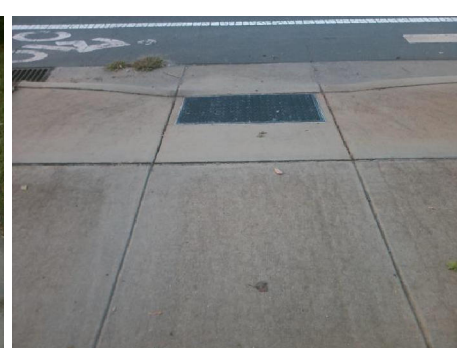
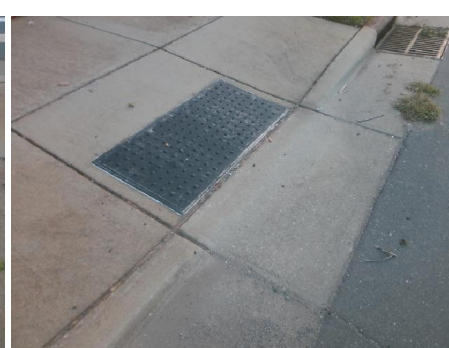
Possible Solutions:		Compliance			Description			Data			
	Remove & Replace Entire Ramp.		N/A	Ramp Length (in)		48.5		No	Ramp Slope (%)		9.3	
			Yes	Ramp Width (in)		52.0		Yes	Ramp XSlope (%)		1.8	
			N/A	Flare Type LT		N/A		N/A	Flare Type RT		N/A	
			N/A	Flare Slope LT (%)		N/A		N/A	Flare Slope RT (%)		N/A	
			N/A	Flare Traversable LT?		N/A		N/A	Flare Traversable RT?		N/A	
			N/A	Landing Length (in)		N/A		N/A	DWS Provided?		N/A	
			N/A	Landing Width (in)		N/A		N/A	DWS Contrast?		N/A	
			N/A	Landing Slope (%)		N/A		N/A	DWS Length (in)		N/A	
			N/A	Landing X Slope (%)		N/A		N/A	DWS Full Width?		N/A	
Surveyor Notes:		N/A			N/A			DWS Offset (in)			N/A	
PROW/ADA:		R304.2.2			N/A							
					N/A			Gutter Ponding?			N/A	
					N/A			Gutter Lip Ht (in)			N/A	
					N/A			Painted X Walk1?			No	
					To S			X Walk 2 Direction			N/A

N/A			X Walk 2 Width (in)			N/A	
					2.6			X Walk 2 Slope (%)			N/A	
					1.3			X Walk 2 X Slope (%)			N/A	
					N/A			Ramp inside XWalk2?			N/A	
					N/A			Clear Space?			N/A	
					N/A			Clear Space to XWalk (in)			N/A	
					N/A			Storm Grate/Utility Hazard?			N/A	
								Storm Grate/Utility Type				
					N/A						N/A	
								Yes			Surface Condition? (G/P)	
											Good
