Access Compliance Report

Public Rights-of-Way

(Curb Ramps)

Intersection ID: 27236		Main Street: BALLANTYNE CORPORATE PCross Street: BRIXHAM HILL AV		Location: NW					
ADA ID: 0E3BBF1BD27B		Ramp Type: BlendTrans1		Initial Pass/Fail: Fail		Overall Compliance: No		Severity Score: 1.25	
Codes/Mitigation Info/Possible Solution					Field Measurements/Component Compliance

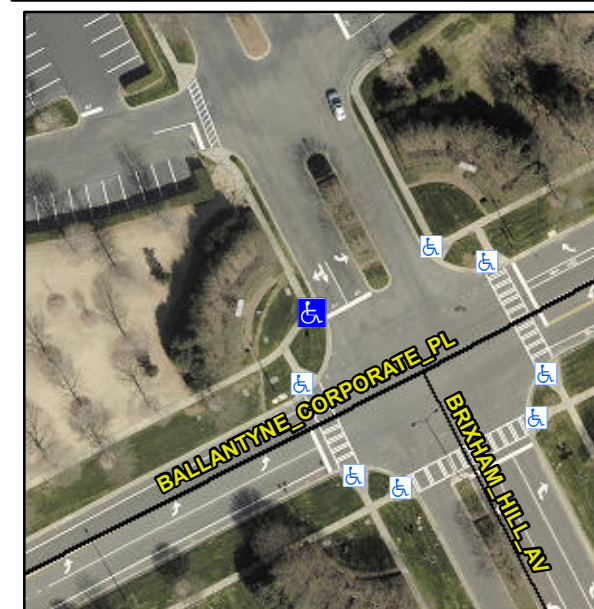
Compliance	Description	Data	Compliance	Description	Data
N/A	Ramp Length (in)	81.0	Yes	BlendTrans Slope (%)	3.9
Yes	Ramp Width (in)	49.0	No	BlendTrans XSlope (%)	4.0
N/A	Flare Type LT	N/A	N/A	Flare Type RT	N/A
N/A	Flare Slope LT (%)	N/A	N/A	Flare Slope RT (%)	N/A
N/A	Flare Traversable LT?	N/A	N/A	Flare Traversable RT?	N/A
N/A	Landing Length (in)	N/A	N/A	DWS Provided?	N/A
N/A	Landing Width (in)	N/A	N/A	DWS Contrast?	N/A
N/A	Landing Slope (%)	N/A	N/A	DWS Length (in)	N/A
N/A	Landing X Slope (%)	N/A	N/A	DWS Full Width?	N/A
N/A	Landing Curb? (Y/N)	N/A	N/A	DWS Offset (in)	N/A
N/A	Shared Landing?	N/A			
N/A	Gutter Ponding?	N/A	N/A	Gutter Slope (%)	N/A
N/A	Gutter Lip Ht (in)	N/A	N/A	Gutter X Slope (%)	N/A
N/A	Painted X Walk1?	No	N/A	Painted X Walk2?	N/A
	X Walk 1 Direction	To NE		X Walk 2 Direction	N/A
	X Walk 1 Width (in)	N/A		X Walk 2 Width (in)	N/A
	X Walk 1 Slope (%)	1.8		X Walk 2 Slope (%)	N/A
	X Walk 1 X Slope (%)	0.8		X Walk 2 X Slope (%)	N/A

N/A	Ramp inside XWalk1?	N/A	N/A	Ramp inside XWalk2?	N/A
	Road Slope (%)	0.8		Clear Space?	N/A
	Road X Slope (%)	1.8	N/A	Clear Space to XWalk (in)	N/A
N/A	Any Obstructions?	N/A	N/A	Storm Grate/Utility Hazard?	N/A
	Obstruction Type			Storm Grate/Utility Type	
		N/A			N/A
			Yes	Surface Condition? (G/P)	Good
			No	Curb Slope (%)	6.0

Possible Solutions:

Remove & Replace Curb Ramp With Two New Directional Ramps or Equivalent.

Not Found, R304.5.3

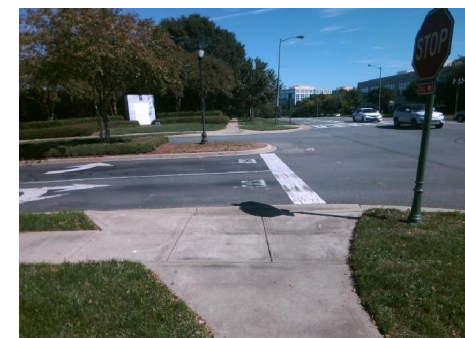
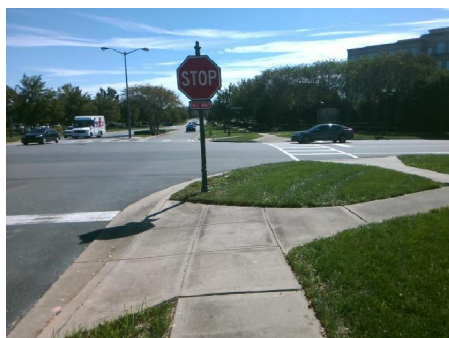
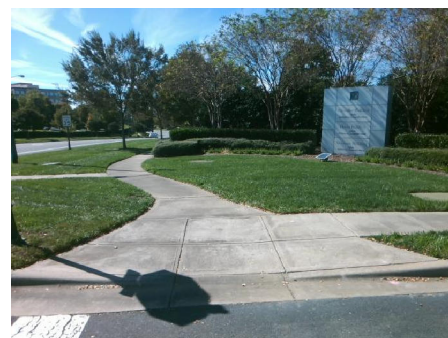
Street 1 Name **BRIXHAM HILL AV**
 Stop Condition-Street 1 **StopSign**
 Street 2 Name **N/A**
 Stop Condition-Street 2 **N/A**
