Access Compliance Report

Public Rights-of-Way

(Curb Ramps)

Intersection ID: 12928	Main Street: PENMAN_ST	Cross Street: QUINCEY_ST	Location:	E
ADA ID: 0E3F9697C052	Ramp Type: PerpDiag	Initial Pass/Fail: Fail	Overall Compliance: No	Severity Score: 12.5

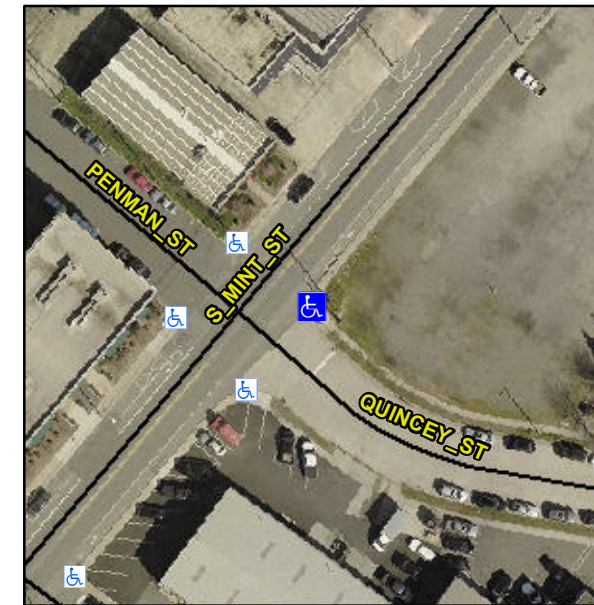
Not Found, R304.2.2

Compliance	Description	Data	Compliance	Description	Data
N/A	Ramp Length (in)	60.0	No	Ramp Slope (%)	10.2
Yes	Ramp Width (in)	48.0	Yes	Ramp XSlope (%)	1.7
N/A	Flare Type LT	N/A	N/A	Flare Type RT	N/A
N/A	Flare Slope LT (%)	N/A	N/A	Flare Slope RT (%)	N/A
N/A	Flare Traversable LT?	N/A	N/A	Flare Traversable RT?	N/A
N/A	Landing Length (in)	N/A	N/A	DWS Provided?	N/A
N/A	Landing Width (in)	N/A	N/A	DWS Contrast?	N/A
N/A	Landing Slope (%)	N/A	N/A	DWS Length (in)	N/A
N/A	Landing X Slope (%)	N/A	N/A	DWS Full Width?	N/A
N/A	Landing Curb? (Y/N)	N/A	N/A	DWS Offset (in)	N/A
N/A	Shared Landing?	N/A			
N/A	Gutter Ponding?	N/A	N/A	Gutter Slope (%)	N/A
N/A	Gutter Lip Ht (in)	N/A	N/A	Gutter X Slope (%)	N/A
N/A	Painted X Walk1?	No	N/A	Painted X Walk2?	No
	X Walk 1 Direction	To NW		X Walk 2 Direction	To SW
N/A	X Walk 1 Width (in)	N/A	N/A	X Walk 2 Width (in)	N/A
	X Walk 1 Slope (%)	4.8		X Walk 2 Slope (%)	5.5
	X Walk 1 X Slope (%)	0.6		X Walk 2 X Slope (%)	0.8

N/A	Ramp inside XWalk1?	N/A	N/A	Ramp inside XWalk2?	N/A
	Road Slope (%)	3.9	N/A	Clear Space?	N/A
	Road X Slope (%)	1.9	N/A	Clear Space to XWalk (in)	N/A
N/A	Any Obstructions?	N/A	N/A	Storm Grate/Utility Hazard?	N/A
	Obstruction Type			Storm Grate/Utility Type	
		N/A			N/A
			Yes	Surface Condition? (G/P)	Good

Remove & Replace Curb Ramp With Two New Directional Ramps or Equivalent.
