Access Compliance Report

Public Rights-of-Way

(Curb Ramps)

Intersection ID: 50338	Main Street: HERMISTON_ST	Cross Street: CASTLECOVE_RD	Location: NE
ADA ID: 0E4B1D62637F	Ramp Type: PerpDiag	Initial Pass/Fail: Fail	Overall Compliance: No
Severity Score: 13.75			
Codes/Mitigation Info/Possible Solution		Field Measurements/Component Compliance

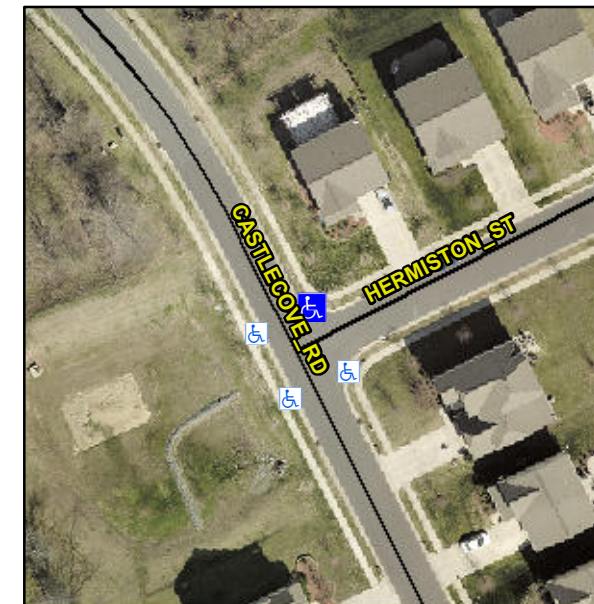
R304.2.2, R304.5.3

Compliance	Description	Data	Compliance	Description	Data
N/A	Ramp Length (in)	45.5	No	Ramp Slope (%)	9.3
Yes	Ramp Width (in)	48.0	No	Ramp XSlope (%)	2.3
N/A	Flare Type LT	N/A	N/A	Flare Type RT	N/A
N/A	Flare Slope LT (%)	N/A	N/A	Flare Slope RT (%)	N/A
N/A	Flare Traversable LT?	N/A	N/A	Flare Traversable RT?	N/A
N/A	Landing Length (in)	N/A	N/A	DWS Provided?	N/A
N/A	Landing Width (in)	N/A	N/A	DWS Contrast?	N/A
N/A	Landing Slope (%)	N/A	N/A	DWS Length (in)	N/A
N/A	Landing X Slope (%)	N/A	N/A	DWS Full Width?	N/A
N/A	Landing Curb? (Y/N)	N/A	N/A	DWS Offset (in)	N/A
N/A	Shared Landing?	N/A			
N/A	Gutter Ponding?	N/A	N/A	Gutter Slope (%)	N/A
N/A	Gutter Lip Ht (in)	N/A	N/A	Gutter X Slope (%)	N/A
N/A	Painted X Walk1?	No	N/A	Painted X Walk2?	No
	X Walk 1 Direction	To SW		X Walk 2 Direction	To SE
N/A	X Walk 1 Width (in)	N/A	N/A	X Walk 2 Width (in)	N/A
	X Walk 1 Slope (%)	1.2		X Walk 2 Slope (%)	1.6
	X Walk 1 X Slope (%)	2.1		X Walk 2 X Slope (%)	0.4

N/A	Ramp inside XWalk1?	N/A	N/A	Ramp inside XWalk2?	N/A
	Road Slope (%)	2.4	N/A	Clear Space?	N/A
	Road X Slope (%)	2.3	N/A	Clear Space to XWalk (in)	N/A
N/A	Any Obstructions?	N/A	N/A	Storm Grate/Utility Hazard?	N/A
	Obstruction Type			Storm Grate/Utility Type	
		N/A			N/A
			Yes	Surface Condition? (G/P)	Good

Possible Solutions:

Remove & Replace Curb Ramp With Two New Directional Ramps or Equivalent.
