# Access Compliance Report

## Public Rights-of-Way

### (Curb Ramps)

| Intersection ID: 31729 | Main Street: ASHBY_HALL_CT | Cross Street: GOLDENWILLOW_DR | Location: | S |

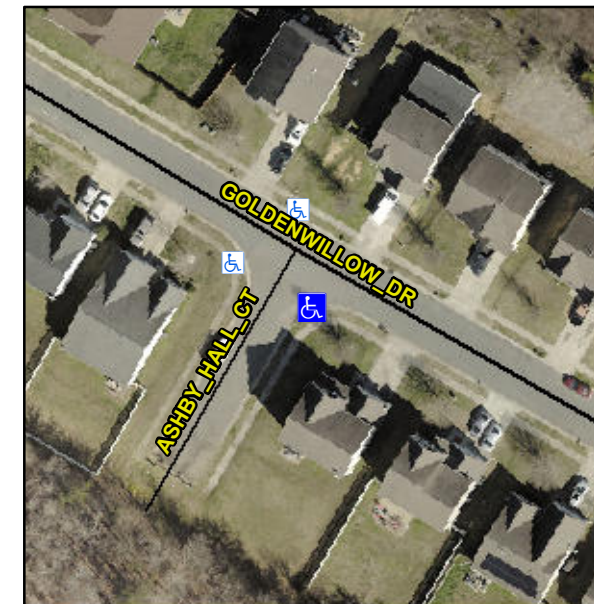
| ADA ID: 0E4FD0D11E73 | Ramp Type: PerpDiag | Initial Pass/Fail: Fail | Overall Compliance: No | Severity Score: 10 |

**Not Found, R304.5.1, R304.5.3**

| Compliance | Description | Data | Compliance | Description | Data |
|---|---|---|---|---|---|
| N/A | Ramp Length (in) | 48.5 | Yes | Ramp Slope (%) | 5.7 |
| No | Ramp Width (in) | 47.5 | No | Ramp XSlope (%) | 3.0 |

**Remove & Replace Curb Ramp With Two New Directional Ramps or Equivalent.**

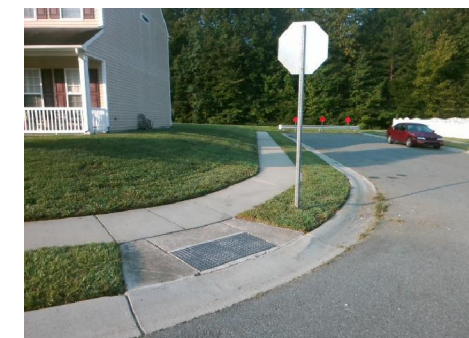
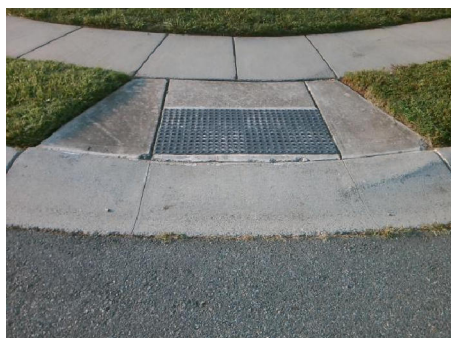
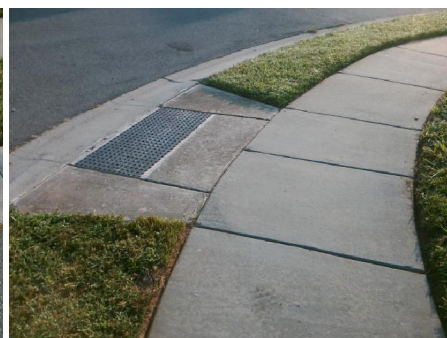
| Compliance | Description | Data | Compliance | Description | Data |
|---|---|---|---|---|---|
| | | | Yes | Surface Condition? (G/P) | Good |
