# Access Compliance Report

## Public Rights-of-Way

### (Curb Ramps)

Intersection ID: 15236	Main Street: CARLING_AV	Cross Street: DILWORTH_RD_EAST	Location: S
ADA ID: 0E5919B8F5A1	Ramp Type: Directional1	Initial Pass/Fail: Fail	Overall Compliance: No
Codes/Mitigation Info/Possible Solution		Field Measurements/Component Compliance	
Severity Score: 26.25

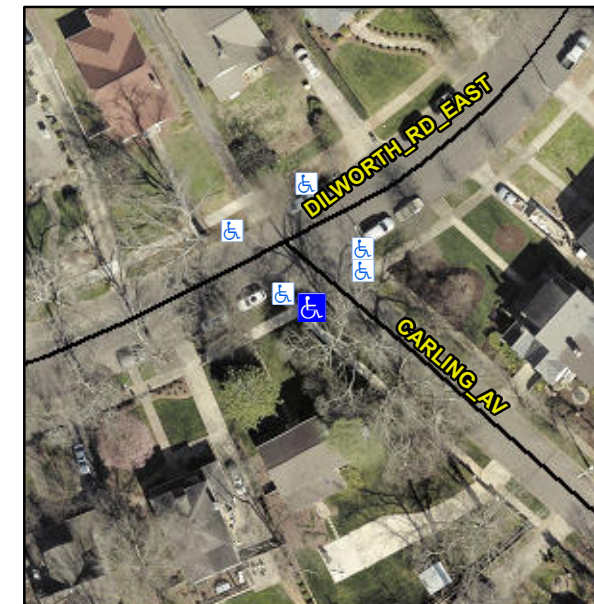
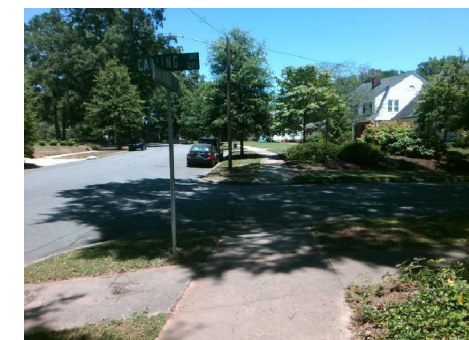
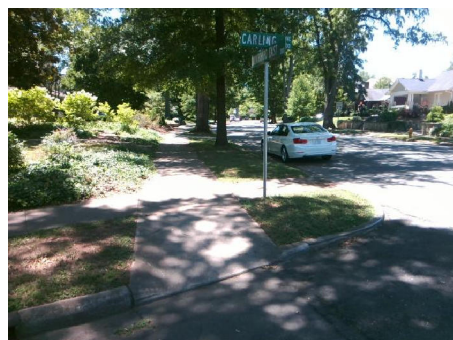
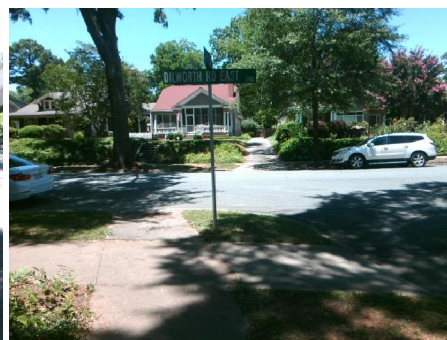
**R304.2.2, R304.5.3**

Compliance	Description	Data	Compliance	Description	Data
N/A	Ramp Length (in)	82.0	N/A	Grade Break?	N/A
Yes	Ramp Width (in)	48.0	N/A	Grade Break Slope (%)	0.0
No	Ramp Slope (%)	12.7	N/A	Grade Break XSlope (%)	0.0
No	Ramp XSlope (%)	3.0			
N/A	Flare Type LT	N/A	N/A	Flare Type RT	N/A
N/A	Flare Slope LT (%)	N/A	N/A	Flare Slope RT (%)	0.0
N/A	Flare Traversable LT?	N/A	N/A	Flare Traversable RT?	N/A
N/A	Landing Length (in)	0.0	N/A	DWS Provided?	N/A
N/A	Landing Width (in)	0.0	N/A	DWS Contrast?	N/A
N/A	Landing Slope (%)	0.0	N/A	DWS Length (in)	N/A
N/A	Landing X Slope (%)	0.0	N/A	DWS Full Width?	N/A
N/A	Landing Curb? (Y/N)	N/A	N/A	DWS Offset LT (in)	N/A
N/A	Shared Landing?	N/A	N/A	DWS Offset RT (in)	N/A
N/A	Gutter Ponding?	0.0	N/A	Gutter Slope (%)	N/A
N/A	Gutter Lip Ht (in)	1.0	N/A	Gutter X Slope (%)	N/A
N/A	Painted X Walk1?	No		Road Slope (%)	4.6
	X Walk 1 Direction	To NE		Road X Slope (%)	3.8
	X Walk 1 Width (in)	N/A		Clear Space?	N/A

X Walk 1 Slope (%)	4.6	N/A	Clear Space to XWalk (in)	N/A
	X Walk 1 X Slope (%)	3.8	N/A	Storm Grate/Utility Hazard?	N/A
N/A	Ramp inside XWalk1?	N/A		Storm Grate/Utility Type	
N/A	Any Obstructions?	N/A			N/A
	Obstruction Type		Yes	Surface Condition? (G/P)	Good
			N/A	Curb Slope (%)	8.7

**Remove & Replace Entire Ramp.**
