Access Compliance Report

Public Rights-of-Way

(Curb Ramps)

Intersection ID: 12134	Main Street: MARLOWE_AV	Cross Street: BERRYHILL_RD	Location: SW
ADA ID: 0E6030C0DCE6	Ramp Type: Perp	Initial Pass/Fail: Fail	Overall Compliance: No
Severity Score: 8.75			
Codes/Mitigation Info/Possible Solution		Field Measurements/Component Compliance

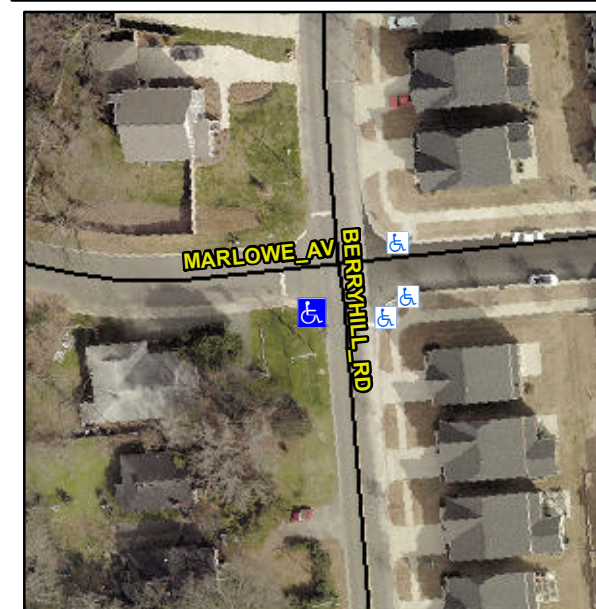
Not Found, R304.5.1

Compliance	Description	Data	Compliance	Description	Data
N/A	Ramp Length (in)	46.0	Yes	Ramp Slope (%)	6.2
No	Ramp Width (in)	47.0	Yes	Ramp XSlope (%)	0.8
N/A	Flare Type LT	N/A	N/A	Flare Type RT	N/A
N/A	Flare Slope LT (%)	N/A	N/A	Flare Slope RT (%)	N/A
N/A	Flare Traversable LT?	N/A	N/A	Flare Traversable RT?	N/A
N/A	Landing Length (in)	N/A	N/A	DWS Provided?	N/A
N/A	Landing Width (in)	N/A	N/A	DWS Contrast?	N/A
N/A	Landing Slope (%)	N/A	N/A	DWS Length (in)	N/A
N/A	Landing X Slope (%)	N/A	N/A	DWS Full Width?	N/A
N/A	Landing Curb? (Y/N)	N/A	N/A	DWS Offset (in)	N/A
N/A	Shared Landing?	N/A			
N/A	Gutter Ponding?	N/A	N/A	Gutter Slope (%)	N/A
N/A	Gutter Lip Ht (in)	N/A	N/A	Gutter X Slope (%)	N/A
N/A	Painted X Walk1?	No	N/A	Painted X Walk2?	N/A
	X Walk 1 Direction	To E		X Walk 2 Direction	N/A
N/A	X Walk 1 Width (in)	N/A	N/A	X Walk 2 Width (in)	N/A
	X Walk 1 Slope (%)	3.4		X Walk 2 Slope (%)	N/A
	X Walk 1 X Slope (%)	3.2		X Walk 2 X Slope (%)	N/A

N/A	Ramp inside XWalk1?	N/A	N/A	Ramp inside XWalk2?	N/A
	Road Slope (%)	N/A	N/A	Clear Space?	N/A
	Road X Slope (%)	N/A	N/A	Clear Space to XWalk (in)	N/A
N/A	Any Obstructions?	N/A	N/A	Storm Grate/Utility Hazard?	N/A
	Obstruction Type			Storm Grate/Utility Type	
		N/A			N/A
		Yes		Surface Condition? (G/P)	Good

Possible Solutions:

Remove & Replace Entire Ramp.
