Access Compliance Report Public Rights-of-Way (Curb Ramps)

Intersection ID: 52718	Main Str	Main Street: AGAVA_LN			Cross Street: MAIDENHAIR_CT			Location:	N
ADA ID: 0E627B9C1A64	Ramp Ty	Ramp Type: Perp			Initial Pass/Fail: Fail Overall Compliance:			o Severity Score:	26.25
Codes/Mitigation Info/Possible Solution				Field Measurements/Component Compliance					
		Possible Solutions:		Compliance Description			Data Compliance Description		
	A Ve	Remove & Replace Entire	Ramp.	N/A	Ramp Length (in)	46.0	No	Ramp Slope (%)	13.1

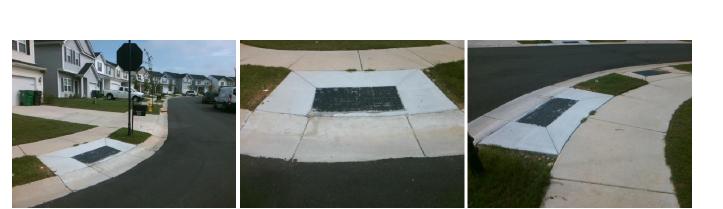
•	Yes	Ramp Width (in)	48.0	No	Ramp XSlope (%)	2.6
1290				N/A	Flare Type LT	N/A	N/A	Flare Type RT	N/A
				N/A	Flare Slope LT (%)	N/A	N/A	Flare Slope RT (%)	N/A
	lash .			N/A	Flare Traversable LT?	N/A	N/A	Flare Traversable RT?	N/A
	9/200			N/A	Landing Length (in)	N/A	N/A	DWS Provided?	N/A
	VA K.	Surveyor Notes:		N/A	Landing Width (in)	N/A	N/A	DWS Contrast?	N/A
	N/A		N/A	Landing Slope (%)	N/A	N/A	DWS Length (in)	N/A	
ALGAVA LIM				N/A	Landing X Slope (%)	N/A	N/A	DWS Full Width?	N/A
6				N/A	Landing Curb? (Y/N)	N/A	N/A	DWS Offset (in)	N/A
				N/A	Shared Landing?	N/A			
	PROW/ADA:		N/A	Gutter Ponding?	N/A	N/A	Gutter Slope (%)	N/A	
	Not Found, R304.2.2, R304	1.5.3	N/A	Gutter Lip Ht (in)	N/A	N/A	Gutter X Slope (%)	N/A	
				N/A	Painted X Walk1?	No	N/A	Painted X Walk2?	N/A
					X Walk 1 Direction	To E		X Walk 2 Direction	N/A
				N/A	X Walk 1 Width (in)	N/A	N/A	X Walk 2 Width (in)	N/A
Street 1 Name	MAIDENHAIR CT	-			X Walk 1 Slope (%)	3.5		X Walk 2 Slope (%)	N/A

Stop Condition-Street 2	StopSign				X Walk 1 X Slope (%)	0.9		X Walk 2 X Slope (%)	N/A
Street 2 Name	N/A			N/A	Ramp inside XWalk1?	N/A	N/A	Ramp inside XWalk2?	N/A
Stop Condition-Street 1	N/A				Road Slope (%)	N/A	N/A	Clear Space?	N/A
					Road X Slope (%)	N/A	N/A	Clear Space to XWalk (in)	N/A
				N/A	Any Obstructions?	N/A	N/A	Storm Grate/Utility Hazard?	N/A
		Total Cost:	\$ 185	0.00	Obstruction Type			Storm Grate/Utility Type	
						N/A			N/A
