Access Compliance Report Public Rights-of-Way (Curb Ramps)

Intersection ID: N/A Main Street: NINA DR Cross Street: W T HARRIS BV Location: SW **Overall Compliance: No** ADA ID: 0E665380D93F Ramp Type: Combination1 Initial Pass/Fail: Fail Severity Score: 58.75

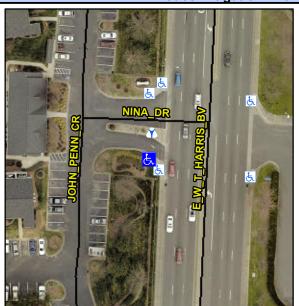
Possible Solutions: Remove & Replace Entire Ramp. Surveyor Notes: RT RP < 5% PROW/ADA Not Found, R304.5.1, R304.5.3, R304.3.2
