Access Compliance Report

Public Rights-of-Way

(Curb Ramps)

Intersection ID: 9579	Main Street: BANCROFT_ST	Cross Street: FRANKLIN_AV	Location: W
ADA ID: 0E6F58E7B272	Ramp Type: Directional1	Initial Pass/Fail: Fail	Overall Compliance: No
		Severity Score: 1.25

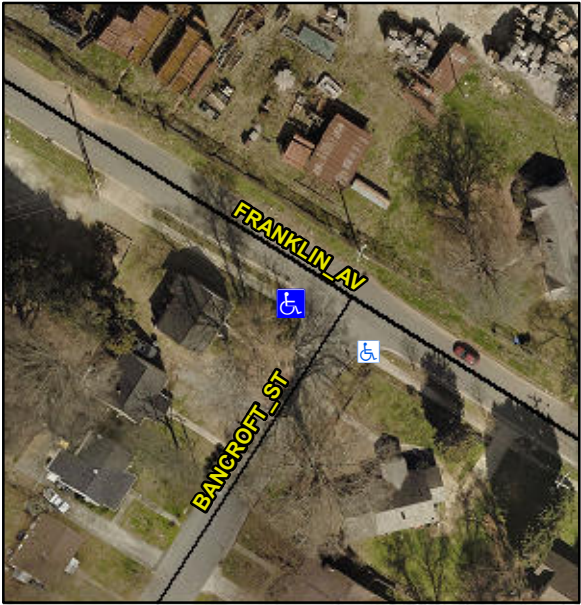
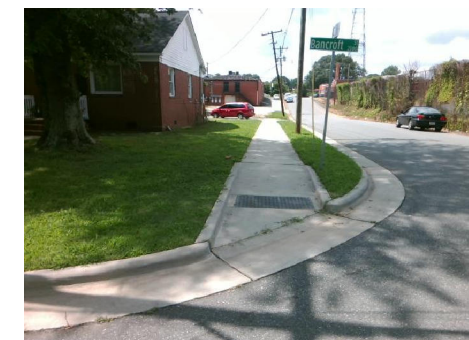
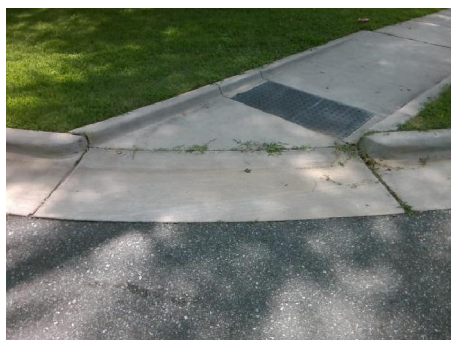
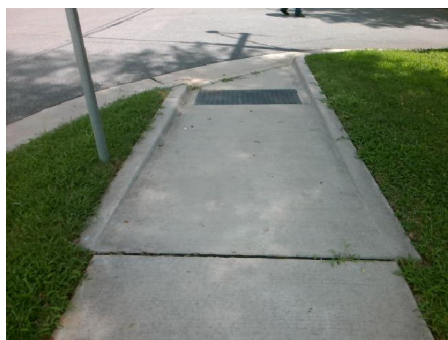
Possible Solutions:				
	Remove & Replace Entire Ramp.				
	Surveyor Notes:				
	N/A				
	PROW/ADA:				
	R304.5.3				
	Street 1 Name	BANCROFT ST			
	Stop Condition-Street 1	StopSign			
	Street 2 Name	N/A			
	Stop Condition-Street 2	N/A			
	Total Cost:	\$ 1600.00			
Compliance	Description	Data	Compliance	Description	Data
N/A	Ramp Length (in)	120.5	N/A	Grade Break?	N/A
Yes	Ramp Width (in)	57.0	N/A	Grade Break Slope (%)	0.0
Yes	Ramp Slope (%)	5.5	N/A	Grade Break XSlope (%)	0.0
No	Ramp XSlope (%)	2.4			
N/A	Flare Type LT	N/A	N/A	Flare Type RT	N/A
N/A	Flare Slope LT (%)	N/A	N/A	Flare Slope RT (%)	0.0
N/A	Flare Traversable LT?	N/A	N/A	Flare Traversable RT?	N/A
N/A	Landing Length (in)	0.0	N/A	DWS Provided?	N/A
N/A	Landing Width (in)	0.0	N/A	DWS Contrast?	N/A
N/A	Landing Slope (%)	0.0	N/A	DWS Length (in)	N/A
N/A	Landing X Slope (%)	0.0	N/A	DWS Full Width?	N/A

N/A	Landing Curb? (Y/N)	N/A	N/A	DWS Offset LT (in)	N/A
N/A	Shared Landing?	N/A	N/A	DWS Offset RT (in)	N/A
N/A	Gutter Ponding?	0.0	N/A	Gutter Slope (%)	N/A
N/A	Gutter Lip Ht (in)	0.0	N/A	Gutter X Slope (%)	N/A
N/A	Painted X Walk1?	No		Road Slope (%)	2.5
	X Walk 1 Direction	To SE		Road X Slope (%)	2.7
	X Walk 1 Width (in)	N/A		Clear Space?	N/A
	X Walk 1 Slope (%)	2.5	N/A	Clear Space to XWalk (in)	N/A
	X Walk 1 X Slope (%)	2.7	N/A	Storm Grate/Utility Hazard?	N/A
N/A	Ramp inside XWalk1?	N/A		Storm Grate/Utility Type	
N/A	Any Obstructions?	N/A			N/A
	Obstruction Type		Yes	Surface Condition? (G/P)	Good
			N/A	Curb Slope (%)	19.8
