Intersection ID: 7111	Main Street: CRICKETEER_DR	Cross Street: NORTHBROOK_DR	Location:	S
ADA ID: 0E7A806F8608	Ramp Type: Perp	Initial Pass/Fail: Fail	Overall Compliance: No	Severity Score: 12.5

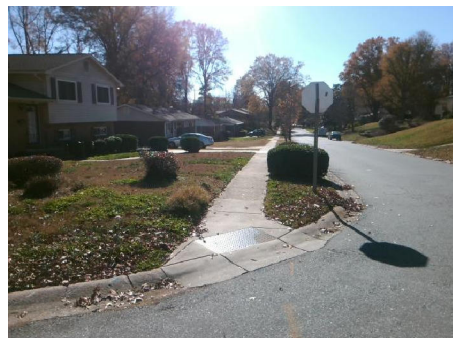
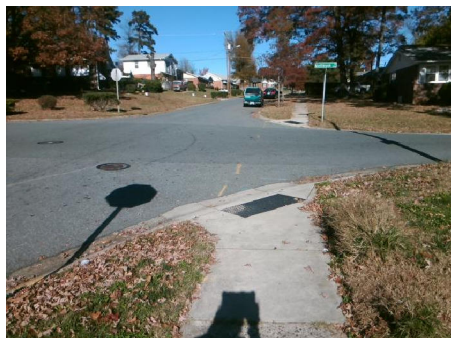
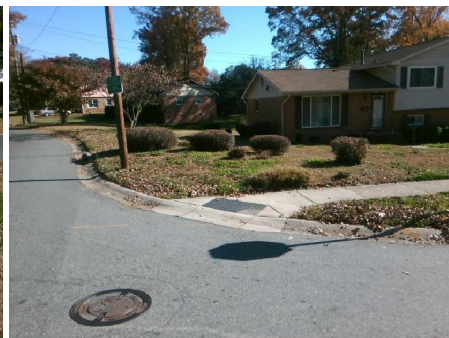
Possible Solutions:			Compliance	Description	Data	Compliance	Description	Data		
Remove & Replace Entire Ramp.			N/A	Ramp Length (in)	25.0	Yes	Ramp Slope (%)	5.6		
			Yes	Ramp Width (in)	48.0	No	Ramp XSlope (%)	5.1		
			N/A	Flare Type LT	N/A	N/A	Flare Type RT	N/A		
			N/A	Flare Slope LT (%)	N/A	N/A	Flare Slope RT (%)	N/A		
			N/A	Flare Traversable LT?	N/A	N/A	Flare Traversable RT?	N/A		
			N/A	Landing Length (in)	N/A	N/A	DWS Provided?	N/A		
			N/A	Landing Width (in)	N/A	N/A	DWS Contrast?	N/A		
			N/A	Landing Slope (%)	N/A	N/A	DWS Length (in)	N/A		
			N/A	Landing X Slope (%)	N/A	N/A	DWS Full Width?	N/A		
			N/A	Landing Curb? (Y/N)	N/A	N/A	DWS Offset (in)	N/A		
Surveyor Notes: N/A			N/A	Shared Landing?	N/A					
			N/A	Gutter Ponding?	N/A	N/A	Gutter Slope (%)	N/A		
			N/A	Gutter Lip Ht (in)	N/A	N/A	Gutter X Slope (%)	N/A		
			N/A	Painted X Walk1?	No	N/A	Painted X Walk2?	N/A		
				X Walk 1 Direction	To NE		X Walk 2 Direction	N/A

N/A	X Walk 1 Width (in)	N/A	N/A	X Walk 2 Width (in)	N/A		
				X Walk 1 Slope (%)	8.6		X Walk 2 Slope (%)	N/A		
				X Walk 1 X Slope (%)	3.6		X Walk 2 X Slope (%)	N/A		
			N/A	Ramp inside XWalk1?	N/A	N/A	Ramp inside XWalk2?	N/A		
				Road Slope (%)	N/A	N/A	Clear Space?	N/A		
PROW/ADA: Not Found, R304.5.3				Road X Slope (%)	N/A	N/A	Clear Space to XWalk (in)	N/A		
			N/A	Any Obstructions?	N/A	N/A	Storm Grate/Utility Hazard?	N/A		
				Obstruction Type			Storm Grate/Utility Type			
					N/A			N/A		
						Yes	Surface Condition? (G/P)	Good		
			Total Cost:			\$	1850.00

Remove & Replace Entire Ramp.
