# Access Compliance Report

## Public Rights-of-Way

### (Curb Ramps)

Intersection ID: 12618	Main Street: E_5TH_ST	Cross Street: N_CALDWELL_ST	Location: NE
ADA ID: 0E81EC665497	Ramp Type: Perp	Initial Pass/Fail: Fail	Overall Compliance: No
			Severity Score: 13.75

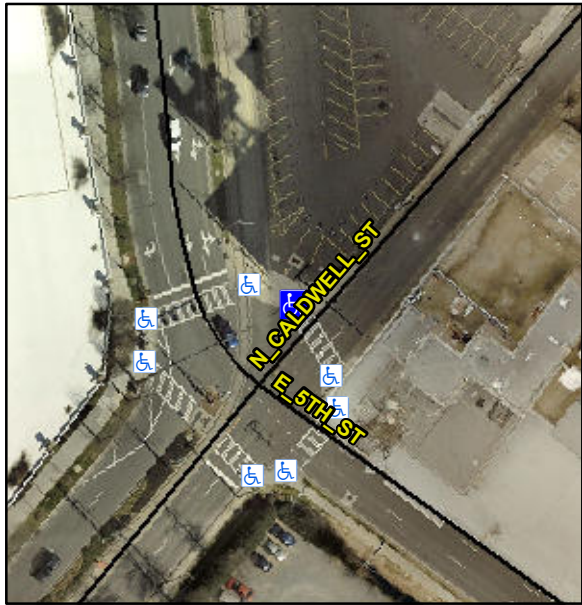
Possible Solutions:		Compliance	Description	Data	Compliance	Description	Data
	Remove & Replace Entire Ramp.		N/A	Ramp Length (in)	78.0	No	Ramp Slope (%)	10.1
			Yes	Ramp Width (in)	48.0	Yes	Ramp XSlope (%)	2.8
			N/A	Flare Type LT	N/A	N/A	Flare Type RT	N/A
			N/A	Flare Slope LT (%)	N/A	N/A	Flare Slope RT (%)	N/A
			N/A	Flare Traversable LT?	N/A	N/A	Flare Traversable RT?	N/A
			N/A	Landing Length (in)	N/A	N/A	DWS Provided?	N/A
			N/A	Landing Width (in)	N/A	N/A	DWS Contrast?	N/A
			N/A	Landing Slope (%)	N/A	N/A	DWS Length (in)	N/A
			N/A	Landing X Slope (%)	N/A	N/A	DWS Full Width?	N/A
Surveyor Notes:			N/A	Landing Curb? (Y/N)	N/A	N/A	DWS Offset (in)	N/A
N/A			N/A	Shared Landing?	N/A			
PROW/ADA:			N/A	Gutter Ponding?	N/A	N/A	Gutter Slope (%)	N/A
Not Found, R304.2.2			N/A	Gutter Lip Ht (in)	N/A	N/A	Gutter X Slope (%)	N/A

N/A	Painted X Walk1?	Yes	N/A	Painted X Walk2?	N/A
				X Walk 1 Direction	To SE		X Walk 2 Direction	N/A
			N/A	X Walk 1 Width (in)	117.0	N/A	X Walk 2 Width (in)	N/A
				X Walk 1 Slope (%)	1.4		X Walk 2 Slope (%)	N/A
				X Walk 1 X Slope (%)	3.4		X Walk 2 X Slope (%)	N/A
			N/A	Ramp inside XWalk1?	Yes	N/A	Ramp inside XWalk2?	N/A
				Road Slope (%)	N/A	N/A	Clear Space?	N/A
				Road X Slope (%)	N/A	N/A	Clear Space to XWalk (in)	N/A
			N/A	Any Obstructions?	N/A	N/A	Storm Grate/Utility Hazard?	N/A
				Obstruction Type			Storm Grate/Utility Type	
					N/A			N/A
						Yes	Surface Condition? (G/P)	Good
