# Access Compliance Report

## Public Rights-of-Way

### (Curb Ramps)

Intersection ID: 20410	Main Street: CARMEL_RD	Cross Street: FAIRVIEW_RD	Location: SE
ADA ID: 0E92B4D0F8C6	Ramp Type: Directional1	Initial Pass/Fail: Fail	Overall Compliance: No
		Severity Score: 10

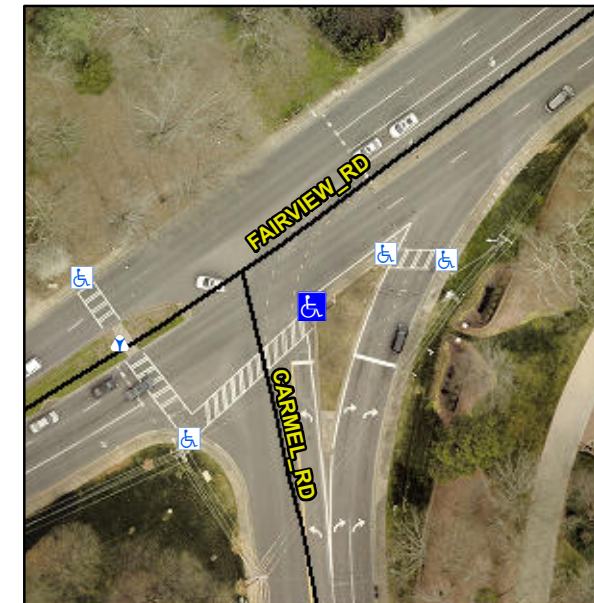
Compliance	Description	Data	Compliance	Description	Data
N/A	Ramp Length (in)	48.0	N/A	Grade Break?	N/A
No	Ramp Width (in)	39.0	N/A	Grade Break Slope (%)	0.0
Yes	Ramp Slope (%)	6.6	N/A	Grade Break XSlope (%)	0.0
Yes	Ramp XSlope (%)	3.0			
N/A	Flare Type LT	N/A	N/A	Flare Type RT	N/A
N/A	Flare Slope LT (%)	N/A	N/A	Flare Slope RT (%)	0.0
N/A	Flare Traversable LT?	N/A	N/A	Flare Traversable RT?	N/A
N/A	Landing Length (in)	0.0	N/A	DWS Provided?	N/A
N/A	Landing Width (in)	0.0	N/A	DWS Contrast?	N/A
N/A	Landing Slope (%)	0.0	N/A	DWS Length (in)	N/A
N/A	Landing X Slope (%)	0.0	N/A	DWS Full Width?	N/A
N/A	Landing Curb? (Y/N)	N/A	N/A	DWS Offset LT (in)	N/A
N/A	Shared Landing?	N/A	N/A	DWS Offset RT (in)	N/A
N/A	Gutter Ponding?	0.0	N/A	Gutter Slope (%)	N/A
N/A	Gutter Lip Ht (in)	0.0	N/A	Gutter X Slope (%)	N/A
N/A	Painted X Walk1?	Yes		Road Slope (%)	0.0
	X Walk 1 Direction	To SW		Road X Slope (%)	4.5
	X Walk 1 Width (in)	127.0		Clear Space?	N/A

X Walk 1 Slope (%)	0.0	N/A	Clear Space to XWalk (in)	N/A
	X Walk 1 X Slope (%)	4.5	N/A	Storm Grate/Utility Hazard?	N/A
N/A	Ramp inside XWalk1?	Yes		Storm Grate/Utility Type	
N/A	Any Obstructions?	N/A			N/A
	Obstruction Type		Yes	Surface Condition? (G/P)	Good
			N/A	Curb Slope (%)	11.6

**Remove & Replace Entire Ramp.**

**R304.5.1**
