## Access Compliance Report Public Rights-of-Way (Curb Ramps)

Intersection ID: 9630 Main Street: N\_SMALLWOOD\_PL Cross Street: W\_TRADE\_ST Location: N

ADA ID: 0E989E5C0AE0 Ramp Type: PerpDiag Initial Pass/Fail: Fail Overall Compliance: No Severity Score: 21.25

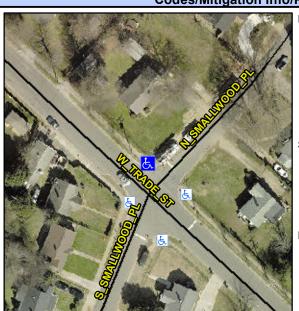
PROW/ADA:
Not Found, R304.5.1, R304.2.2

Compliance Description Data Compliance Description Data No N/A Ramp Length (in) 48.5 Ramp Slope (%) 8.6 Yes No Ramp Width (in) 47.0 Ramp XSlope (%) 1.3 N/A N/A Flare Type LT N/A Flare Type RT N/A N/A N/A N/A Flare Slope RT (%) N/A Flare Slope LT (%) N/A Flare Traversable LT? N/A N/A Flare Traversable RT? N/A N/A N/A N/A DWS Provided? N/A Landing Length (in) N/A Landing Width (in) N/A N/A **DWS Contrast?** N/A N/A N/A N/A Landing Slope (%) DWS Length (in) N/A N/A Landing X Slope (%) N/A N/A DWS Full Width? N/A N/A Landing Curb? (Y/N) N/A N/A DWS Offset (in) N/A N/A N/A Shared Landing? N/A **Gutter Ponding?** N/A N/A Gutter Slope (%) N/A N/A Gutter Lip Ht (in) N/A N/A Gutter X Slope (%) N/A N/A Painted X Walk1? No N/A Painted X Walk2? No X Walk 1 Direction To SW X Walk 2 Direction To SE N/A N/A X Walk 1 Width (in) X Walk 2 Width (in) N/A X Walk 1 Slope (%) 3.2 X Walk 2 Slope (%) 4.5 X Walk 1 X Slope (%) 3.0 X Walk 2 X Slope (%) 3.7 N/A N/A N/A Ramp inside XWalk2? N/A Ramp inside XWalk1? Road Slope (%) 2.4 N/A Clear Space? N/A N/A Road X Slope (%) 5.8 Clear Space to XWalk (in) N/A N/A N/A N/A Any Obstructions? Storm Grate/Utility Hazard? N/A **Obstruction Type** Storm Grate/Utility Type N/A N/A Yes Surface Condition? (G/P) Good

Remove & Replace Curb Ramp With
Two New Directional Ramps or
Equivalent.
