Access Compliance Report Public Rights-of-Way (Curb Ramps)

Intersection ID: 18576 Main Street: WAKEFIELD_DR Cross Street: PINEHURST_PL Location: NE

ADA ID: 0EA88989D0F3 Ramp Type: PerpDiag Initial Pass/Fail: Fail Overall Compliance: No Severity Score: 12.5

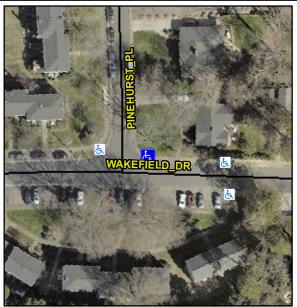
r icia measarements/component compnance							
	Compliance Description		Data	Compliance		Description	Data
	N/A	Ramp Length (in)	31.0	Yes	Ramp	Slope (%)	5.7
	Yes	Ramp Width (in)	48.0	No	Ramp	XSlope (%)	5.4
	N/A	Flare Type LT	N/A	N/A	Flare	Type RT	N/A
	N/A	Flare Slope LT (%)	N/A	N/A	Flare	Slope RT (%)	N/A
	N/A	Flare Traversable LT?	N/A	N/A	Flare	Traversable RT?	N/A
	N/A	Landing Length (in)	N/A	N/A	DWS	Provided?	N/A
	N/A	Landing Width (in)	N/A	N/A	DWS	Contrast?	N/A
	N/A	Landing Slope (%)	N/A	N/A	DWS	Length (in)	N/A
	N/A	Landing X Slope (%)	N/A	N/A	DWS	Full Width?	N/A
	N/A	Landing Curb? (Y/N)	N/A	N/A	DWS	Offset (in)	N/A
	N/A	Shared Landing?	N/A				
	N/A	Gutter Ponding?	N/A	N/A	Gutter	Slope (%)	N/A
	N/A	Gutter Lip Ht (in)	N/A	N/A	Gutter	X Slope (%)	N/A
	N/A	Painted X Walk1?	No	N/A	Painte	ed X Walk2?	No
		X Walk 1 Direction	To NW		X Wall	k 2 Direction	To S
	N/A	X Walk 1 Width (in)	N/A	N/A	X Wall	k 2 Width (in)	N/A

X Walk 1 Slope (%)	5.3		X Wall	k 2 Slope (%)	2.6
		X Walk 1 X Slope (%)	3.1		X Wall	k 2 X Slope (%)	4.8
	N/A	Ramp inside XWalk1?	N/A	N/A	Ramp	inside XWalk2?	N/A
		Road Slope (%)	5.0	N/A	Clear	Space?	N/A
		Road X Slope (%)	0.6	N/A	Clear	Space to XWalk (in)	N/A

Remove & Replace Curb Ramp With Two New Directional Ramps or Equivalent.

Not Found, R304.5.3
