## Access Compliance Report Public Rights-of-Way (Curb Ramps)

Intersection ID: 13754 Main Street: S\_MCDOWELL\_ST Cross Street: BAXTER\_ST Location: W

ADA ID: 0EB5A5150EA3 Ramp Type: PerpDiag Initial Pass/Fail: Fail Overall Compliance: No Severity Score: 12.5

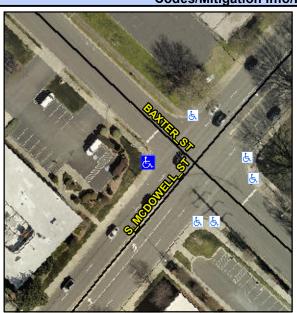
Not Found, R304.2.2

rield Measurements/Component Compilance							
	Comp	Compliance Description		Compliance Description		Data	
	N/A	Ramp Length (in)	78.0	No	Ramp Slope (%)	10.8	
	Yes	Ramp Width (in)	54.0	Yes	Ramp XSlope (%)	1.4	
	N/A	Flare Type LT	N/A	N/A	Flare Type RT	N/A	
	N/A	Flare Slope LT (%)	N/A	N/A	Flare Slope RT (%)	N/A	
	N/A	Flare Traversable LT?	N/A	N/A	Flare Traversable RT?	N/A	
	N/A	Landing Length (in)	N/A	N/A	DWS Provided?	N/A	
	N/A	Landing Width (in)	N/A	N/A	DWS Contrast?	N/A	
	N/A	Landing Slope (%)	N/A	N/A	DWS Length (in)	N/A	
	N/A	Landing X Slope (%)	N/A	N/A	DWS Full Width?	N/A	
	N/A	Landing Curb? (Y/N)	N/A	N/A	DWS Offset (in)	N/A	
	N/A	Shared Landing?	N/A				
	N/A	Gutter Ponding?	N/A	N/A	Gutter Slope (%)	N/A	
	N/A	Gutter Lip Ht (in)	N/A	N/A	Gutter X Slope (%)	N/A	
	N/A	Painted X Walk1?	No	N/A	Painted X Walk2?	No	
		X Walk 1 Direction	To SE		X Walk 2 Direction	To NE	
	N/A	X Walk 1 Width (in)	N/A	N/A	X Walk 2 Width (in)	N/A

X Walk 1 Slope (%)	5.0		X Walk 2 Slope (%)	5.6	
		X Walk 1 X Slope (%)	3.6		X Walk 2 X Slope (%)	3.3	
	N/A	Ramp inside XWalk1?	N/A	N/A	Ramp inside XWalk2?	N/A	
		Road Slope (%)	0.2	N/A	Clear Space?	N/A	
		Road X Slope (%)	4.2	N/A	Clear Space to XWalk (in)	N/A

Remove & Replace Curb Ramp With Two New Directional Ramps or Equivalent.
