# Access Compliance Report

## Public Rights-of-Way (Curb Ramps)

| Intersection ID: 11304 | Main Street: NATIONS_FORD_RD | Cross Street: MARSHALL_AIR_DR | Location: SE |
| ADA ID: 0EB6C9AD02DF | Ramp Type: Perp | Initial Pass/Fail: Fail | Overall Compliance: No |

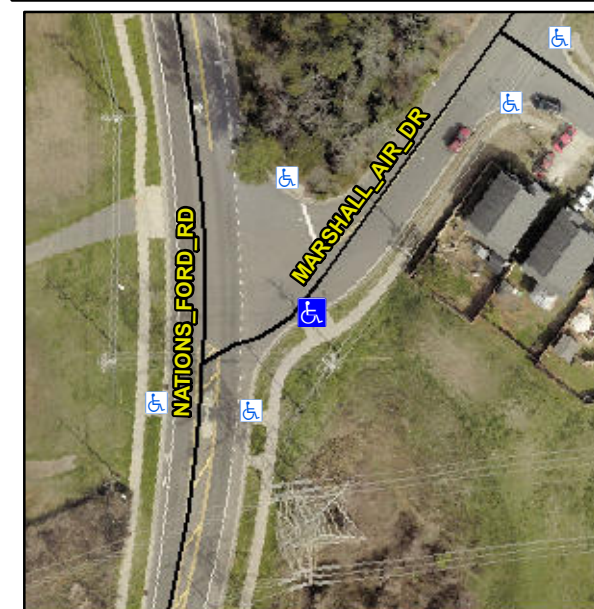
**Not Found, R304.5.1, R304.2.2, R304.5.3**

| Compliance | Description | Data | Compliance | Description | Data |
|---|---|---|---|---|---|
| N/A | Ramp Length (in) | 96.0 | No | Ramp Slope (%) | 8.8 |
| No | Ramp Width (in) | 46.5 | No | Ramp XSlope (%) | 4.2 |

**Remove & Replace Entire Ramp.**

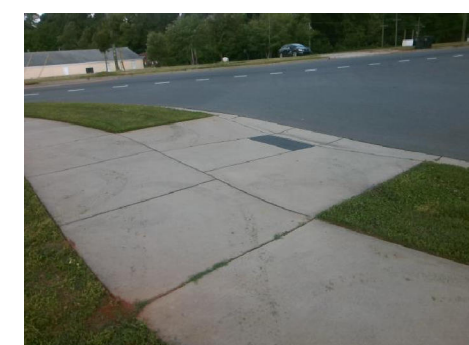
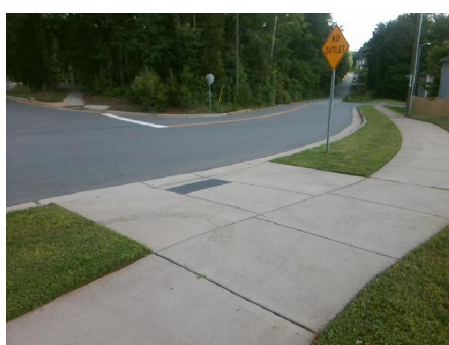
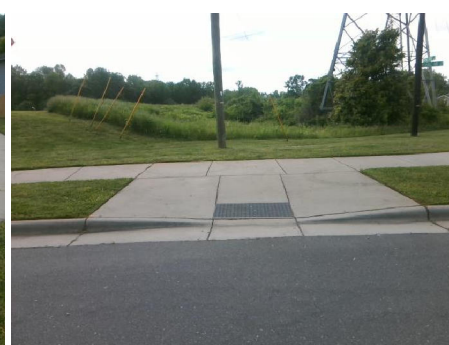
| Compliance | Description | Data | Compliance | Description | Data |
|---|---|---|---|---|---|
| | | | Yes | Surface Condition? (G/P) | Good |
