# Access Compliance Report

## Public Rights-of-Way

### (Curb Ramps)

Intersection ID: N/A	Main Street: SHOPTON_RD	Cross Street: ROCK_ISLAND_RD	Location: S
ADA ID: 0EBCCFC290AA	Ramp Type: BlendTrans1	Initial Pass/Fail: Fail	Overall Compliance: No
Codes/Mitigation Info/Possible Solution		Field Measurements/Component Compliance	
Severity Score: 10

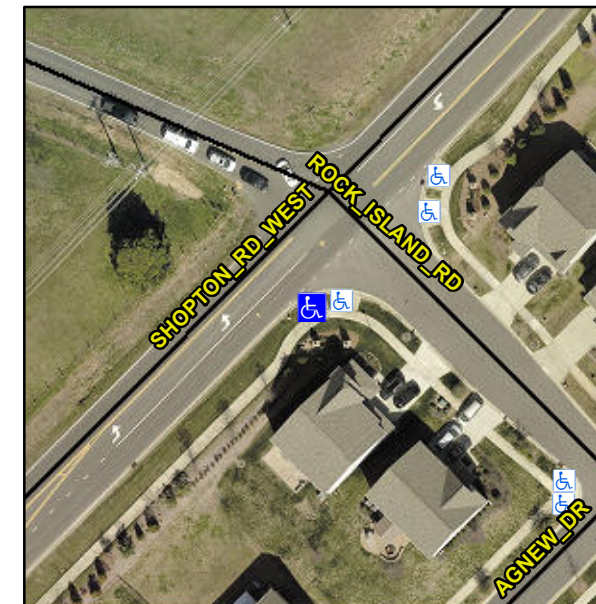
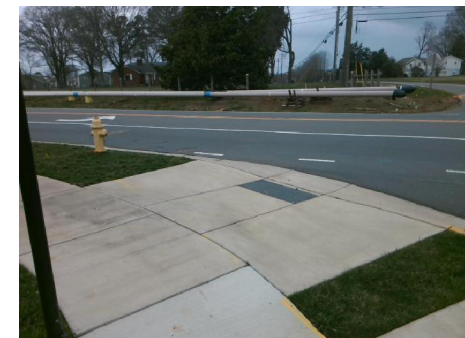
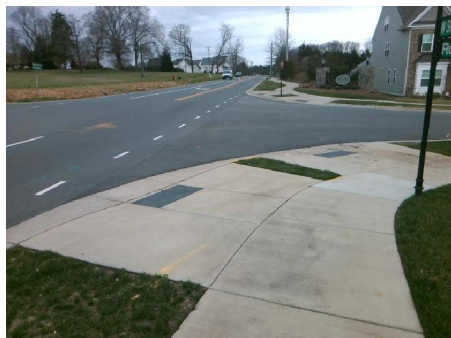
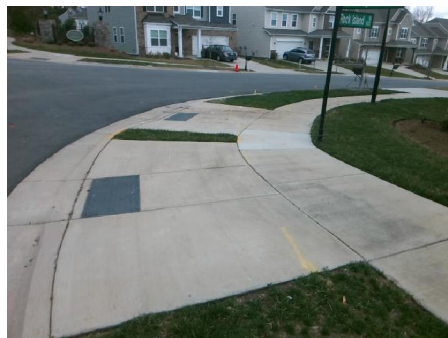
Compliance	Description	Data	Compliance	Description	Data
N/A	Ramp Length (in)	94.0	Yes	BlendTrans Slope (%)	3.9
No	Ramp Width (in)	45.5	No	BlendTrans XSlope (%)	2.2
N/A	Flare Type LT	N/A	N/A	Flare Type RT	N/A
N/A	Flare Slope LT (%)	N/A	N/A	Flare Slope RT (%)	N/A
N/A	Flare Traversable LT?	N/A	N/A	Flare Traversable RT?	N/A
N/A	Landing Length (in)	N/A	N/A	DWS Provided?	N/A
N/A	Landing Width (in)	N/A	N/A	DWS Contrast?	N/A
N/A	Landing Slope (%)	N/A	N/A	DWS Length (in)	N/A
N/A	Landing X Slope (%)	N/A	N/A	DWS Full Width?	N/A
N/A	Landing Curb? (Y/N)	N/A	N/A	DWS Offset (in)	N/A
N/A	Shared Landing?	N/A			
N/A	Gutter Ponding?	N/A	N/A	Gutter Slope (%)	N/A
N/A	Gutter Lip Ht (in)	N/A	N/A	Gutter X Slope (%)	N/A
N/A	Painted X Walk1?	No	N/A	Painted X Walk2?	N/A
	X Walk 1 Direction	To NW		X Walk 2 Direction	N/A
	X Walk 1 Width (in)	N/A		X Walk 2 Width (in)	N/A
	X Walk 1 Slope (%)	4.5		X Walk 2 Slope (%)	N/A
	X Walk 1 X Slope (%)	1.1		X Walk 2 X Slope (%)	N/A

N/A	Ramp inside XWalk1?	N/A	N/A	Ramp inside XWalk2?	N/A
	Road Slope (%)	1.1		Clear Space?	N/A
	Road X Slope (%)	4.5	N/A	Clear Space to XWalk (in)	N/A
N/A	Any Obstructions?	N/A	N/A	Storm Grate/Utility Hazard?	N/A
	Obstruction Type			Storm Grate/Utility Type	
		N/A			N/A
			Yes	Surface Condition? (G/P)	Good
			N/A	Curb Slope (%)	5.0

**Remove & Replace Curb Ramp With Two New Directional Ramps or Equivalent.**

**R304.5.1, R304.5.3**
