Access Compliance Report

Public Rights-of-Way

(Curb Ramps)

Intersection ID: 8262	Main Street: HOVIS_RD	Cross Street: MARBLE_ST	Location: SE
ADA ID: 0EC0DEDFA7FA	Ramp Type: Directional1	Initial Pass/Fail: Fail	Overall Compliance: No
Severity Score: 12.5			
Codes/Mitigation Info/Possible Solution		Field Measurements/Component Compliance

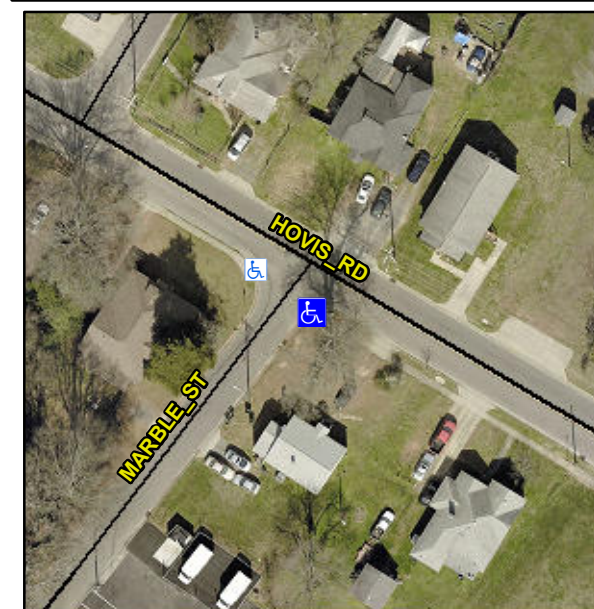
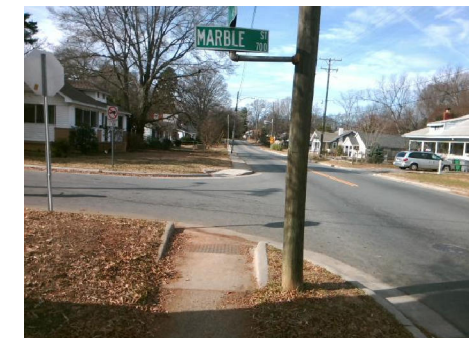
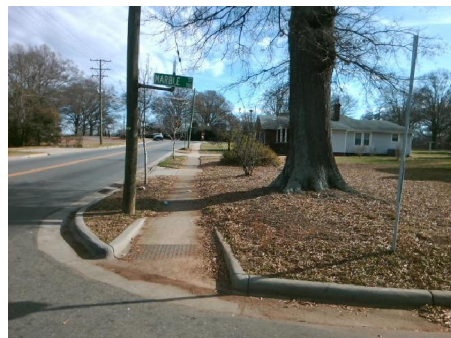
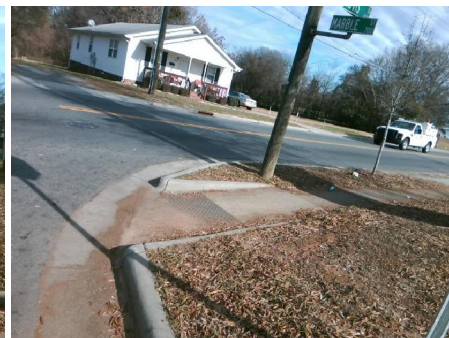
R304.2.2

Compliance	Description	Data	Compliance	Description	Data
N/A	Ramp Length (in)	88.0	N/A	Grade Break?	N/A
Yes	Ramp Width (in)	48.0	N/A	Grade Break Slope (%)	0.0
No	Ramp Slope (%)	8.4	N/A	Grade Break XSlope (%)	0.0
Yes	Ramp XSlope (%)	1.2			
N/A	Flare Type LT	N/A	N/A	Flare Type RT	N/A
N/A	Flare Slope LT (%)	N/A	N/A	Flare Slope RT (%)	0.0
N/A	Flare Traversable LT?	N/A	N/A	Flare Traversable RT?	N/A
N/A	Landing Length (in)	0.0	N/A	DWS Provided?	N/A
N/A	Landing Width (in)	0.0	N/A	DWS Contrast?	N/A
N/A	Landing Slope (%)	0.0	N/A	DWS Length (in)	N/A
N/A	Landing X Slope (%)	0.0	N/A	DWS Full Width?	N/A
N/A	Landing Curb? (Y/N)	N/A	N/A	DWS Offset LT (in)	N/A
N/A	Shared Landing?	N/A	N/A	DWS Offset RT (in)	N/A
N/A	Gutter Ponding?	Yes	N/A	Gutter Slope (%)	N/A
N/A	Gutter Lip Ht (in)	0.0	N/A	Gutter X Slope (%)	N/A
N/A	Painted X Walk1?	No		Road Slope (%)	0.2
	X Walk 1 Direction	To NW		Road X Slope (%)	1.3
	X Walk 1 Width (in)	N/A		Clear Space?	N/A

Remove & Replace Entire Ramp.

\$ 1600.00
