Access Compliance Report

Public Rights-of-Way

(Curb Ramps)

Intersection ID: 14946	Main Street: DILWORTH_RD_WEST	Cross Street: E WORTHINGTON AV	Location: W
ADA ID: 0EC247F53CCB	Ramp Type: Perp	Initial Pass/Fail: Fail	Overall Compliance: No
Severity Score: 22.5			
Codes/Mitigation Info/Possible Solution		Field Measurements/Component Compliance

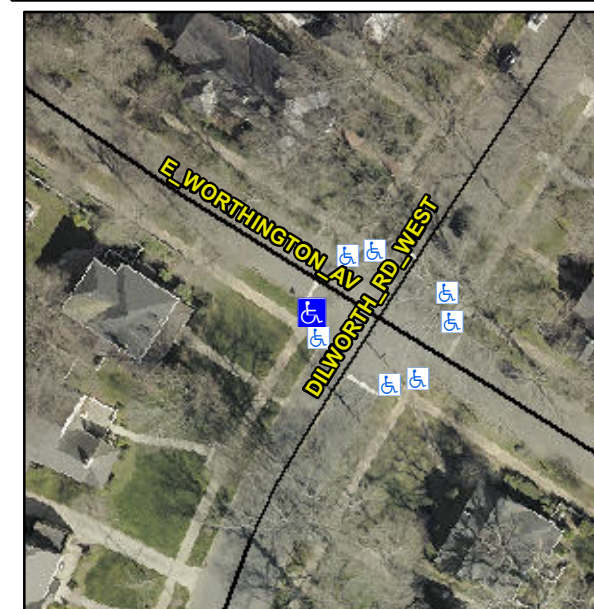
Compliance	Description	Data	Compliance	Description	Data
N/A	Ramp Length (in)	58.0	No	Ramp Slope (%)	8.7
No	Ramp Width (in)	46.0	No	Ramp XSlope (%)	3.4
N/A	Flare Type LT	N/A	N/A	Flare Type RT	N/A
N/A	Flare Slope LT (%)	N/A	N/A	Flare Slope RT (%)	N/A
N/A	Flare Traversable LT?	N/A	N/A	Flare Traversable RT?	N/A
N/A	Landing Length (in)	N/A	N/A	DWS Provided?	N/A
N/A	Landing Width (in)	N/A	N/A	DWS Contrast?	N/A
N/A	Landing Slope (%)	N/A	N/A	DWS Length (in)	N/A
N/A	Landing X Slope (%)	N/A	N/A	DWS Full Width?	N/A
N/A	Landing Curb? (Y/N)	N/A	N/A	DWS Offset (in)	N/A
N/A	Shared Landing?	N/A			
N/A	Gutter Ponding?	N/A	N/A	Gutter Slope (%)	N/A
N/A	Gutter Lip Ht (in)	N/A	N/A	Gutter X Slope (%)	N/A
N/A	Painted X Walk1?	No	N/A	Painted X Walk2?	N/A
	X Walk 1 Direction	To NE		X Walk 2 Direction	N/A
N/A	X Walk 1 Width (in)	N/A	N/A	X Walk 2 Width (in)	N/A
	X Walk 1 Slope (%)	4.1		X Walk 2 Slope (%)	N/A
	X Walk 1 X Slope (%)	1.9		X Walk 2 X Slope (%)	N/A

N/A	Ramp inside XWalk1?	N/A	N/A	Ramp inside XWalk2?	N/A
	Road Slope (%)	N/A	N/A	Clear Space?	N/A
	Road X Slope (%)	N/A	N/A	Clear Space to XWalk (in)	N/A
N/A	Any Obstructions?	N/A	N/A	Storm Grate/Utility Hazard?	N/A
	Obstruction Type			Storm Grate/Utility Type	
		N/A			N/A
			Yes	Surface Condition? (G/P)	Good

Possible Solutions:

Remove & Replace Entire Ramp.

R304.5.1, R304.2.2, R304.5.3

Total Cost: \$ 1850.00
