Access Compliance Report

Public Rights-of-Way

(Curb Ramps)

| Intersection ID: 21910 | Main Street: CARMEL_RD | Cross Street: COLONY_RD | Location: E |

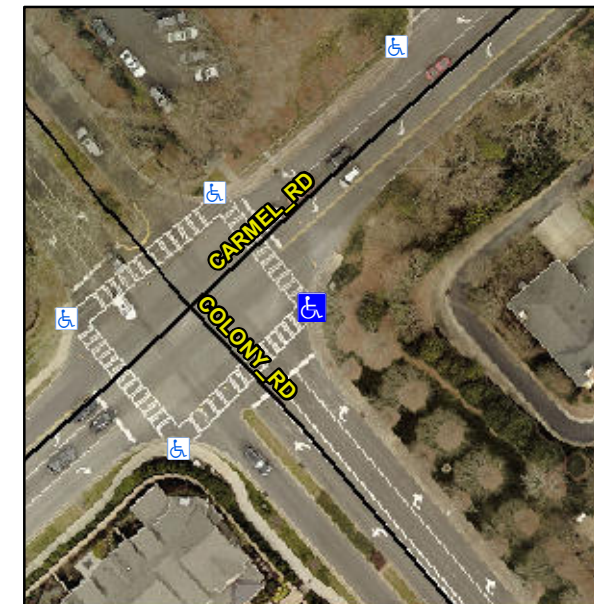
| ADA ID: 0EC35A8DC08C | Ramp Type: PerpDiag | Initial Pass/Fail: Fail | Overall Compliance: No |
| Severity Score: 12.5 | | | |

Not Found, R304.2.2

| Compliance | Description | Data | Compliance | Description | Data |
|---|---|---|---|---|---|
| N/A | Ramp Length (in) | 60.0 | No | Ramp Slope (%) | 11.1 |
| Yes | Ramp Width (in) | 56.0 | Yes | Ramp XSlope (%) | 1.5 |

Remove & Replace Curb Ramp With Two New Directional Ramps or Equivalent.

Total Cost: \$ 3200.00

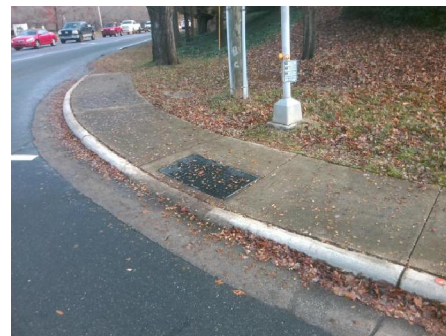
| Compliance | Description | Data | Compliance | Description | Data |
|---|---|---|---|---|---|
| | | Yes | | Surface Condition? (G/P) | Good |
