# Access Compliance Report

## Public Rights-of-Way

| Intersection ID: 30015 | Main Street: MOORGATE_RD | Cross Street: YEARWOOD_LN | Location: NW |
| ADA ID: 0ED5ACAA2EB5 | Ramp Type: PerpDiag | Initial Pass/Fail: Fail | Overall Compliance: No |

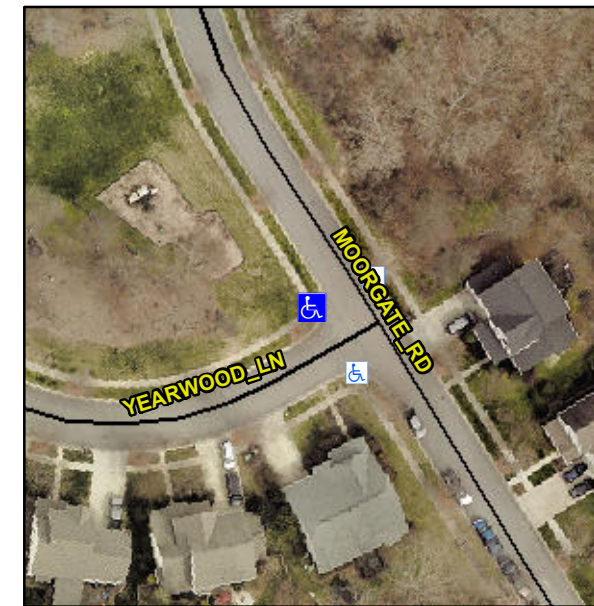
| | | Severity Score: 12.5 | |

**Not Found, R304.5.3**

| Compliance | Description | Data | Compliance | Description | Data |
|---|---|---|---|---|---|
| Yes | Ramp Width (in) | 48.0 | No | Ramp XSlope (%) | 5.5 |

**Remove & Replace Curb Ramp With Two New Directional Ramps or Equivalent.**

Total Cost: \$ 3200.00

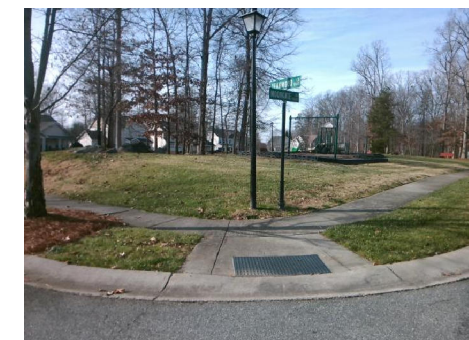
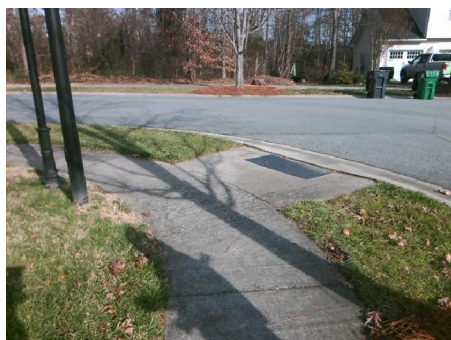
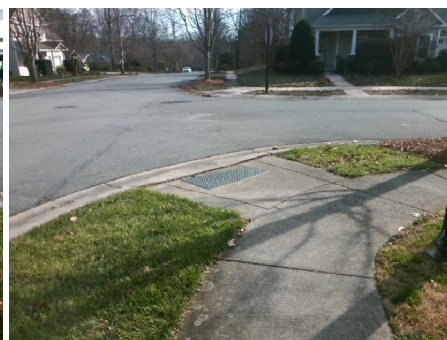
Street 1 Name YEARWOOD LN  
 Stop Condition-Street 2 StopSign  
 Street 2 Name MOORGATE RD  
 Stop Condition-Street 1 None
