Access Compliance Report Public Rights-of-Way (Curb Ramps)

Intersection ID: 54156 Main Street: OAKDALE_RIDGE_RD Cross Street: MAPLE_CREEK_CT Location: SW

ADA ID: 0ED7FFF97DBB Ramp Type: BlendTrans1 Initial Pass/Fail: Fail Overall Compliance: No Severity Score: 8.75

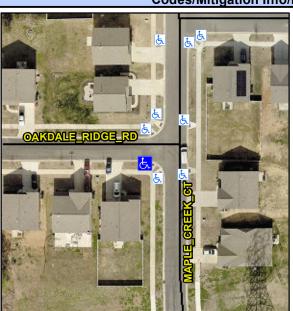
Not Found, R304.5.1

Field Measurements/Component Compliance					
Compliance Description		Data	Compliance Description		Data
N/A	Ramp Length (in)	96.0	Yes	BlendTrans Slope (%)	1.9
No	Ramp Width (in)	46.5	Yes	BlendTrans XSlope (%)	1.0
N/A	Flare Type LT	N/A	N/A	Flare Type RT	N/A
N/A	Flare Slope LT (%)	N/A	N/A	Flare Slope RT (%)	N/A
N/A	Flare Traversable LT?	N/A	N/A	Flare Traversable RT?	N/A
N/A	Landing Length (in)	N/A	N/A	DWS Provided?	N/A
N/A	Landing Width (in)	N/A	N/A	DWS Contrast?	N/A
N/A	Landing Slope (%)	N/A	N/A	DWS Length (in)	N/A
N/A	Landing X Slope (%)	N/A	N/A	DWS Full Width?	N/A
N/A	Landing Curb? (Y/N)	N/A	N/A	DWS Offset (in)	N/A
N/A	Shared Landing?	N/A			
N/A	Gutter Ponding?	N/A	N/A	Gutter Slope (%)	N/A
N/A	Gutter Lip Ht (in)	1.5	N/A	Gutter X Slope (%)	N/A
N/A	Painted X Walk1?	No	N/A	Painted X Walk2?	N/A
	X Walk 1 Direction	To N		X Walk 2 Direction	N/A
	X Walk 1 Width (in)	N/A		X Walk 2 Width (in)	N/A
	X Walk 1 Slope (%)	0.1		X Walk 2 Slope (%)	N/A

X Walk 1 X Slope (%)	0.3		X Walk 2 X Slope (%)	N/A
N/A	Ramp inside XWalk1?	N/A	N/A	Ramp inside XWalk2?	N/A
	Road Slope (%)	0.3		Clear Space?	N/A
	Road X Slope (%)	0.1	N/A	Clear Space to XWalk (in)	N/A
N/A	Any Obstructions?	N/A	N/A	Storm Grate/Utility Hazard?	N/A
	Obstruction Type			Storm Grate/Utility Type	
		N/A			N/A
			Yes	Surface Condition? (G/P)	Good

Remove & Replace Curb Ramp With Two New Directional Ramps or Equivalent.
