Access Compliance Report Public Rights-of-Way (Curb Ramps)

Intersection ID: 5104 Main Street: E_MALLARD_CREEK_CHURCHCIROB's Street: MARY_ALEXANDER_RD Location:

Overall Compliance: No Severity Score: 46.25 ADA ID: 0EDBC5F27BCC Ramp Type: Perp Initial Pass/Fail: Fail

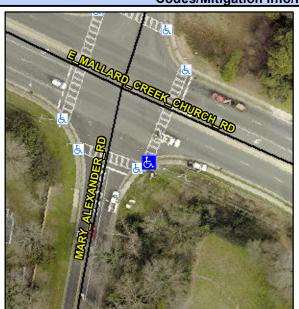
Field Measurements/Component Compliance								
Compl	iance Description	Data	Comp	liance Description	Data			
N/A	Ramp Length (in)	72.0	No	Ramp Slope (%)	9.1			
No	Ramp Width (in)	47.0	No	Ramp XSlope (%)	11.0			
N/A	Flare Type LT	N/A	N/A	Flare Type RT	N/A			
N/A	Flare Slope LT (%)	N/A	N/A	Flare Slope RT (%)	N/A			
N/A	Flare Traversable LT?	N/A	N/A	Flare Traversable RT?	N/A			
N/A	Landing Length (in)	N/A	N/A	DWS Provided?	N/A			
N/A	Landing Width (in)	N/A	N/A	DWS Contrast?	N/A			
N/A	Landing Slope (%)	N/A	N/A	DWS Length (in)	N/A			
N/A	Landing X Slope (%)	N/A	N/A	DWS Full Width?	N/A			
N/A	Landing Curb? (Y/N)	N/A	N/A	DWS Offset (in)	N/A			
N/A	Shared Landing?	N/A						
N/A	Gutter Ponding?	N/A	N/A	Gutter Slope (%)	N/A			
N/A	Gutter Lip Ht (in)	N/A	N/A	Gutter X Slope (%)	N/A			
N/A	Painted X Walk1?	Yes	N/A	Painted X Walk2?	N/A			
	X Walk 1 Direction	To NE		X Walk 2 Direction	N/A			
N/A	X Walk 1 Width (in)	111.0	N/A	X Walk 2 Width (in)	N/A

X Walk 1 Slope (%)	3.9		X Walk 2 Slope (%)	N/A			
	X Walk 1 X Slope (%)	8.6		X Walk 2 X Slope (%)	N/A			
N/A	Ramp inside XWalk1?	Yes	N/A	Ramp inside XWalk2?	N/A			
	Road Slope (%)	N/A	N/A	Clear Space?	N/A			
	Road X Slope (%)	N/A	N/A	Clear Space to XWalk (in)	N/A			
N/A	Any Obstructions?	N/A	N/A	Storm Grate/Utility Hazard?	N/A			
	Obstruction Type			Storm Grate/Utility Type				
		N/A			N/A			
			Yes	Surface Condition? (G/P)	Good

0001810 001811011		
Possible Solutions:	0	
Remove & Replace Entire Ramp.		
	N	
	N	
	N	
	N	
	N	
Surveyor Notes:	N	
N/A	N	
	N	
	N	
	N	
PROW/ADA:	N	
R304.5.1, R304.2.2, R304.5.3	N	
	N	
	N

Total Cost:	\$	1850.00
