Access Compliance Report

Public Rights-of-Way

(Curb Ramps)

Intersection ID: 15072	Main Street: DILWORTH_RD_EAST	Cross Street: E WORTHINGTON AV	Location: S
ADA ID: 0EEE7077F650	Ramp Type: Directional1	Initial Pass/Fail: Fail	Overall Compliance: No
Codes/Mitigation Info/Possible Solution		Field Measurements/Component Compliance	
Severity Score: 13.75

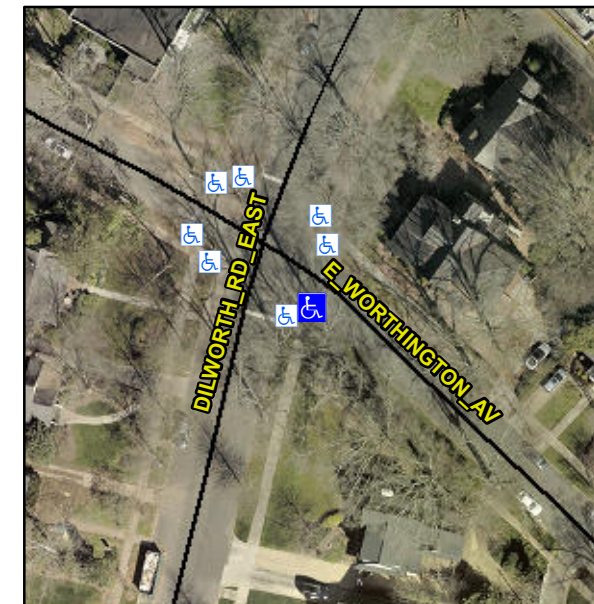
R304.2.2, R304.5.3

Compliance	Description	Data	Compliance	Description	Data
N/A	Ramp Length (in)	91.0	N/A	Grade Break?	N/A
Yes	Ramp Width (in)	60.0	N/A	Grade Break Slope (%)	0.0
No	Ramp Slope (%)	10.0	N/A	Grade Break XSlope (%)	0.0
No	Ramp XSlope (%)	2.4			
N/A	Flare Type LT	N/A	N/A	Flare Type RT	N/A
N/A	Flare Slope LT (%)	N/A	N/A	Flare Slope RT (%)	0.0
N/A	Flare Traversable LT?	N/A	N/A	Flare Traversable RT?	N/A
N/A	Landing Length (in)	0.0	N/A	DWS Provided?	N/A
N/A	Landing Width (in)	0.0	N/A	DWS Contrast?	N/A
N/A	Landing Slope (%)	0.0	N/A	DWS Length (in)	N/A
N/A	Landing X Slope (%)	0.0	N/A	DWS Full Width?	N/A
N/A	Landing Curb? (Y/N)	N/A	N/A	DWS Offset LT (in)	N/A
N/A	Shared Landing?	N/A	N/A	DWS Offset RT (in)	N/A
N/A	Gutter Ponding?	0.0	N/A	Gutter Slope (%)	N/A
N/A	Gutter Lip Ht (in)	1.0	N/A	Gutter X Slope (%)	N/A
N/A	Painted X Walk1?	No		Road Slope (%)	3.9
	X Walk 1 Direction	To N		Road X Slope (%)	1.7
	X Walk 1 Width (in)	N/A		Clear Space?	N/A

X Walk 1 Slope (%)	3.9	N/A	Clear Space to XWalk (in)	N/A
	X Walk 1 X Slope (%)	1.7	N/A	Storm Grate/Utility Hazard?	N/A
N/A	Ramp inside XWalk1?	N/A		Storm Grate/Utility Type	
N/A	Any Obstructions?	N/A			N/A
	Obstruction Type		Yes	Surface Condition? (G/P)	Good
			N/A	Curb Slope (%)	21.3

Remove & Replace Entire Ramp.
