Access Compliance Report

Public Rights-of-Way

(Curb Ramps)

Intersection ID: 2822	Main Street: CARDINAL_POINT_RD	Cross Street: GOLDENBLUSH_CR	Location: S
ADA ID: 0EF3CF0006EF	Ramp Type: Perp	Initial Pass/Fail: Fail	Overall Compliance: No
Severity Score: 10			
Codes/Mitigation Info/Possible Solution		Field Measurements/Component Compliance

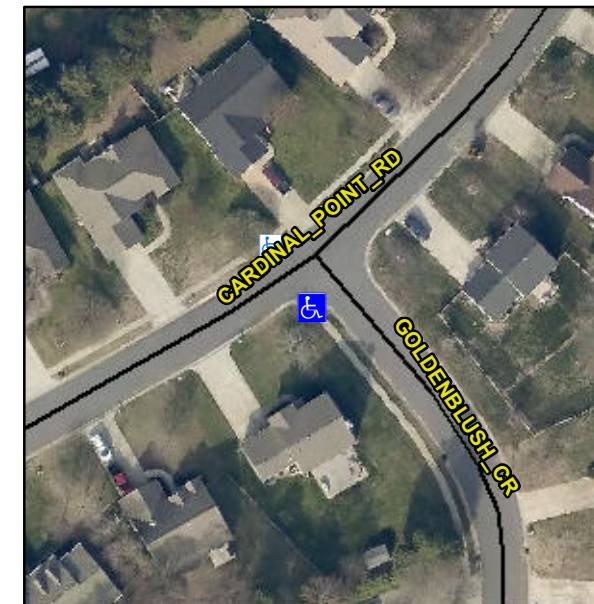
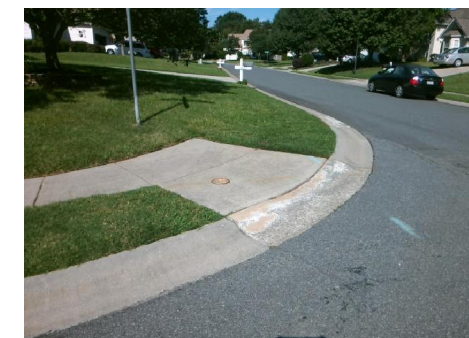
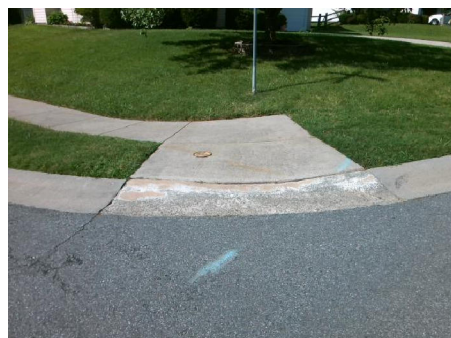
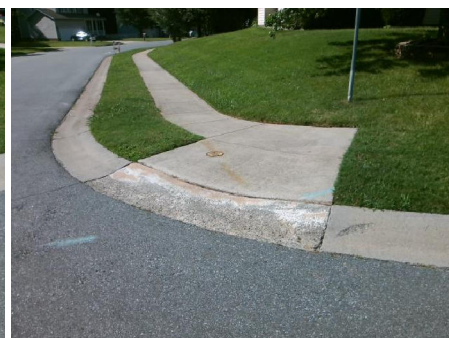
Not Found, R304.5.1

Compliance	Description	Data	Compliance	Description	Data
N/A	Ramp Length (in)	48.0	Yes	Ramp Slope (%)	5.0
No	Ramp Width (in)	43.0	Yes	Ramp XSlope (%)	3.3
N/A	Flare Type LT	N/A	N/A	Flare Type RT	N/A
N/A	Flare Slope LT (%)	N/A	N/A	Flare Slope RT (%)	N/A
N/A	Flare Traversable LT?	N/A	N/A	Flare Traversable RT?	N/A
N/A	Landing Length (in)	N/A	N/A	DWS Provided?	N/A
N/A	Landing Width (in)	N/A	N/A	DWS Contrast?	N/A
N/A	Landing Slope (%)	N/A	N/A	DWS Length (in)	N/A
N/A	Landing X Slope (%)	N/A	N/A	DWS Full Width?	N/A
N/A	Landing Curb? (Y/N)	N/A	N/A	DWS Offset (in)	N/A
N/A	Shared Landing?	N/A			
N/A	Gutter Ponding?	N/A	N/A	Gutter Slope (%)	N/A
N/A	Gutter Lip Ht (in)	N/A	N/A	Gutter X Slope (%)	N/A
N/A	Painted X Walk1?	No	N/A	Painted X Walk2?	N/A
	X Walk 1 Direction	To NW		X Walk 2 Direction	N/A
N/A	X Walk 1 Width (in)	N/A	N/A	X Walk 2 Width (in)	N/A
	X Walk 1 Slope (%)	3.1		X Walk 2 Slope (%)	N/A
	X Walk 1 X Slope (%)	4.9		X Walk 2 X Slope (%)	N/A

N/A	Ramp inside XWalk1?	N/A	N/A	Ramp inside XWalk2?	N/A
	Road Slope (%)	N/A	N/A	Clear Space?	N/A
	Road X Slope (%)	N/A	N/A	Clear Space to XWalk (in)	N/A
N/A	Any Obstructions?	N/A	N/A	Storm Grate/Utility Hazard?	N/A
	Obstruction Type			Storm Grate/Utility Type	
		N/A			N/A
			Yes	Surface Condition? (G/P)	Good

Remove & Replace Entire Ramp.
