# Access Compliance Report

## Public Rights-of-Way

### (Curb Ramps)

| Intersection ID: 13736 | Main Street: CAMDEN_RD | Cross Street: E_PARK_AV | Location: | N |

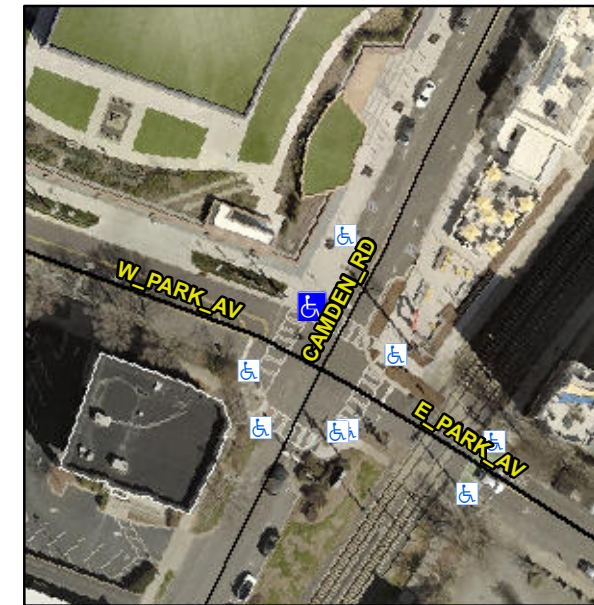
| ADA ID: 0EFEE16D153D | Ramp Type: PerpDiag | Initial Pass/Fail: Fail | Overall Compliance: No | Severity Score: 1.25 |

**R304.5.3**

| Compliance | Description | Data | Compliance | Description | Data |
|---|---|---|---|---|---|
| N/A | Ramp Length (in) | 88.0 | Yes | Ramp Slope (%) | 5.4 |
| Yes | Ramp Width (in) | 61.0 | No | Ramp XSlope (%) | 2.2 |

**Remove & Replace Curb Ramp With Two New Directional Ramps or Equivalent.**

Total Cost: \$ 3200.00
