Access Compliance Report

Public Rights-of-Way

(Curb Ramps)

Intersection ID: 12274	Main Street: BERRYHILL_RD	Cross Street: MORTON_ST	Location: NW
ADA ID: 0F02BC836CF8	Ramp Type: BlendTrans2	Initial Pass/Fail: Fail	Overall Compliance: No
		Severity Score: 8.75

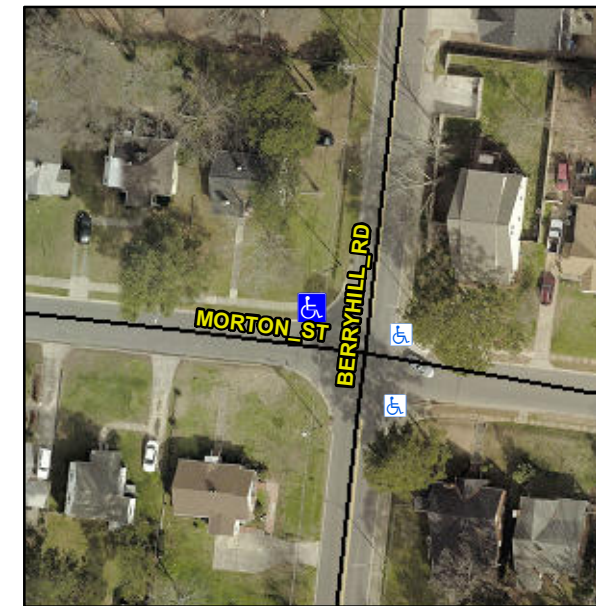
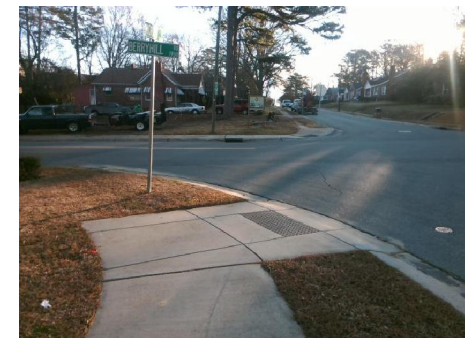
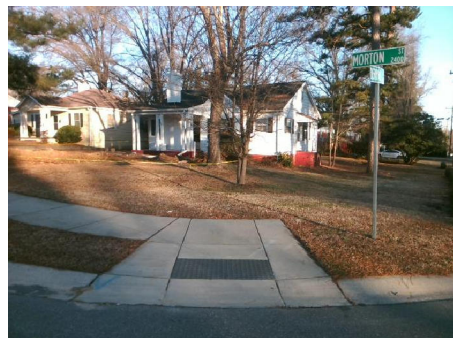
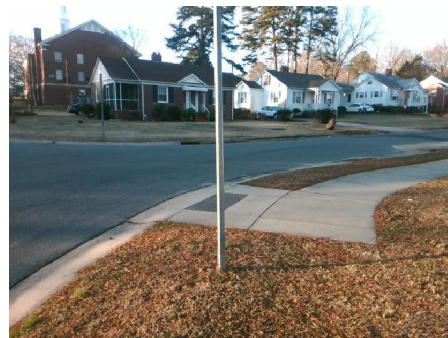
Not Found, R304.5.1

Compliance	Description	Data	Compliance	Description	Data
N/A	Ramp Length (in)	108.5	Yes	BlendTrans Slope (%)	2.6
No	Ramp Width (in)	47.0	Yes	BlendTrans XSlope (%)	1.9
N/A	Flare Type LT	N/A	N/A	Flare Type RT	N/A
N/A	Flare Slope LT (%)	N/A	N/A	Flare Slope RT (%)	N/A
N/A	Flare Traversable LT?	N/A	N/A	Flare Traversable RT?	N/A
N/A	Landing Length (in)	N/A	N/A	DWS Provided?	N/A
N/A	Landing Width (in)	N/A	N/A	DWS Contrast?	N/A
N/A	Landing Slope (%)	N/A	N/A	DWS Length (in)	N/A
N/A	Landing X Slope (%)	N/A	N/A	DWS Full Width?	N/A
N/A	Landing Curb? (Y/N)	N/A	N/A	DWS Offset (in)	N/A
N/A	Shared Landing?	N/A			
N/A	Gutter Ponding?	N/A	N/A	Gutter Slope (%)	N/A
N/A	Gutter Lip Ht (in)	N/A	N/A	Gutter X Slope (%)	N/A
N/A	Painted X Walk1?	No	N/A	Painted X Walk2?	N/A
	X Walk 1 Direction	To E		X Walk 2 Direction	N/A
	X Walk 1 Width (in)	N/A		X Walk 2 Width (in)	N/A
	X Walk 1 Slope (%)	1.3		X Walk 2 Slope (%)	N/A
	X Walk 1 X Slope (%)	6.4		X Walk 2 X Slope (%)	N/A

N/A	Ramp inside XWalk1?	N/A	N/A	Ramp inside XWalk2?	N/A
	Road Slope (%)	6.4		Clear Space?	N/A
	Road X Slope (%)	1.3	N/A	Clear Space to XWalk (in)	N/A
N/A	Any Obstructions?	N/A	N/A	Storm Grate/Utility Hazard?	N/A
	Obstruction Type			Storm Grate/Utility Type	
		N/A			N/A
			Yes	Surface Condition? (G/P)	Good
			No	Curb Slope (%)	9.8

Remove & Replace Curb Ramp With Two New Directional Ramps or Equivalent.

Total Cost: \$ 3200.00
