# Access Compliance Report

## Public Rights-of-Way

### (Curb Ramps)

| Intersection ID: 16088 | Main Street: OXFORD_PL | Cross Street: QUEENS_RD | Location: SE |

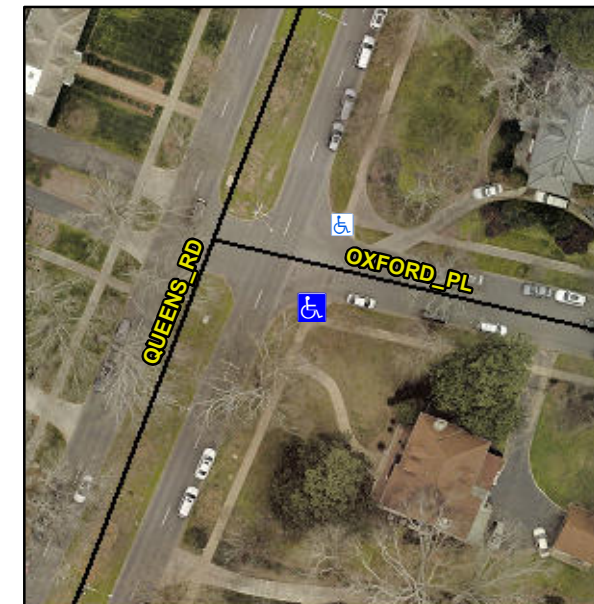
| ADA ID: 0F0AE3B9BB72 | Ramp Type: Directional1 | Initial Pass/Fail: Fail | Overall Compliance: No |
| | | Severity Score: 1.25 | |

**R304.5.3**

| Compliance | Description | Data | Compliance | Description | Data |
|---|---|---|---|---|---|
| No | Ramp XSlope (%) | 2.2 | | | |

**Remove & Replace Entire Ramp.**

\$ 1600.00
