Access Compliance Report

Public Rights-of-Way (Curb Ramps)

Intersection ID: 48606	Main Street: PIEDMONT_ROW_DR	Cross Street: CARNEGIE_BV	Location: SW
ADA ID: 0F15E466D623	Ramp Type: Directional1	Initial Pass/Fail: Fail	Overall Compliance: No
		Severity Score: 1.25

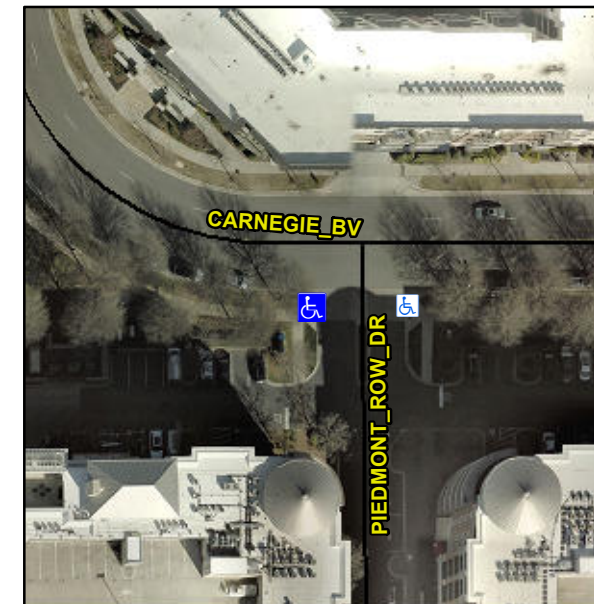
Compliance	Description	Data	Compliance	Description	Data
N/A	Ramp Length (in)	26.0	N/A	Grade Break?	N/A
Yes	Ramp Width (in)	48.0	N/A	Grade Break Slope (%)	0.0
Yes	Ramp Slope (%)	4.6	N/A	Grade Break XSlope (%)	0.0
No	Ramp XSlope (%)	3.5			
N/A	Flare Type LT	N/A	N/A	Flare Type RT	N/A
N/A	Flare Slope LT (%)	N/A	N/A	Flare Slope RT (%)	0.0
N/A	Flare Traversable LT?	N/A	N/A	Flare Traversable RT?	N/A
N/A	Landing Length (in)	0.0	N/A	DWS Provided?	N/A
N/A	Landing Width (in)	0.0	N/A	DWS Contrast?	N/A
N/A	Landing Slope (%)	0.0	N/A	DWS Length (in)	N/A
N/A	Landing X Slope (%)	0.0	N/A	DWS Full Width?	N/A
N/A	Landing Curb? (Y/N)	N/A	N/A	DWS Offset LT (in)	N/A
N/A	Shared Landing?	N/A	N/A	DWS Offset RT (in)	N/A
N/A	Gutter Ponding?	0.0	N/A	Gutter Slope (%)	N/A
N/A	Gutter Lip Ht (in)	0.0	N/A	Gutter X Slope (%)	N/A
N/A	Painted X Walk1?	No		Road Slope (%)	1.9
	X Walk 1 Direction	To E		Road X Slope (%)	2.1
	X Walk 1 Width (in)	N/A		Clear Space?	N/A

X Walk 1 Slope (%)	1.9	N/A	Clear Space to XWalk (in)	N/A
	X Walk 1 X Slope (%)	2.1	N/A	Storm Grate/Utility Hazard?	N/A
N/A	Ramp inside XWalk1?	N/A		Storm Grate/Utility Type	
N/A	Any Obstructions?	N/A			N/A
	Obstruction Type		Yes	Surface Condition? (G/P)	Good
			N/A	Curb Slope (%)	1.5

Remove & Replace Entire Ramp.

R304.5.3

\$ 1600.00
