# Access Compliance Report

## Public Rights-of-Way

### (Curb Ramps)

| Intersection ID: 2513 | Main Street: BENTGRASS_RUN_DR | Cross Street: COPPERMINE_LN | Location: SE |

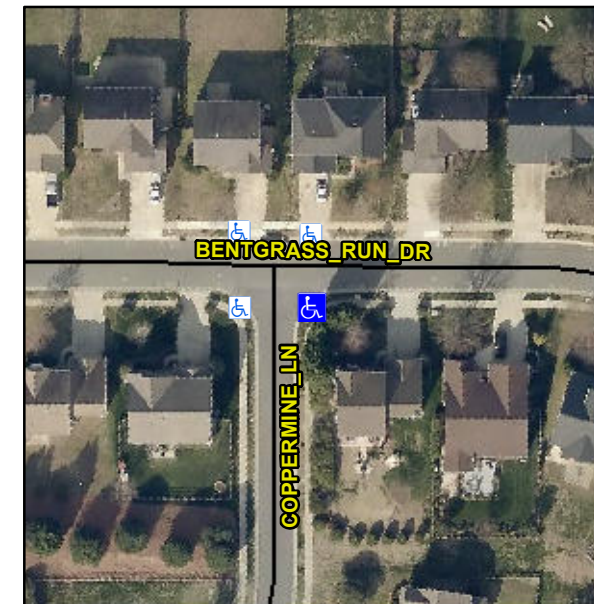
| ADA ID: 0F1A393BE44C | Ramp Type: PerpDiag | Initial Pass/Fail: Pass | Overall Compliance: No |
| | | Severity Score: 15 | |

| Compliance | Description | Data | Compliance | Description | Data |
|---|---|---|---|---|---|
| Yes | Landing Length (in) | 48.0 | No | DWS Provided? | No |
| No | Landing Slope (%) | 4.0 | N/A | DWS Length (in) | N/A |
| No | Landing X Slope (%) | 2.3 | N/A | DWS Full Width? | No |
| Yes | Gutter Ponding? | No | No | Gutter Slope (%) | 6.0 |

Possible Solutions:

**Remove & Replace Curb Ramp With Two New Directional Ramps or Equivalent. Remove & Replace Gutter.**

**R304.2.2-Perp, R304.3.2-Para, R304.5.3, R305, R304.5.4**

Total Cost: \$ 3950.00
