Access Compliance Report

Public Rights-of-Way

(Curb Ramps)

| Intersection ID: 13587 | Main Street: E_HILL_ST | Cross Street: ROYAL_CT | Location: E |

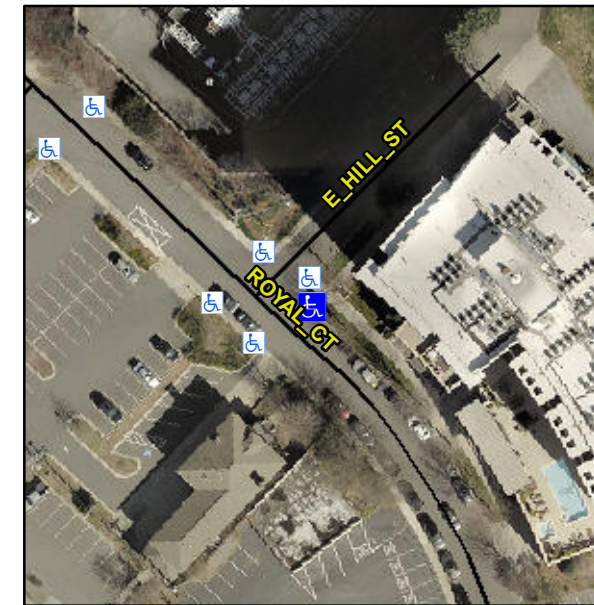
| ADA ID: 0F1B22587C5E | Ramp Type: Perp | Initial Pass/Fail: Fail | Overall Compliance: No |

Not Found, R304.5.3

| Compliance | Description | Data | Compliance | Description | Data |
|---|---|---|---|---|---|
| Yes | Ramp Width (in) | 60.0 | No | Ramp XSlope (%) | 5.5 |

Remove & Replace Entire Ramp.
