Access Compliance Report

Public Rights-of-Way

(Curb Ramps)

| Intersection ID: 15398 | Main Street: COLVILLE_RD | Cross Street: HEMPSTEAD_PL | Location: SE |

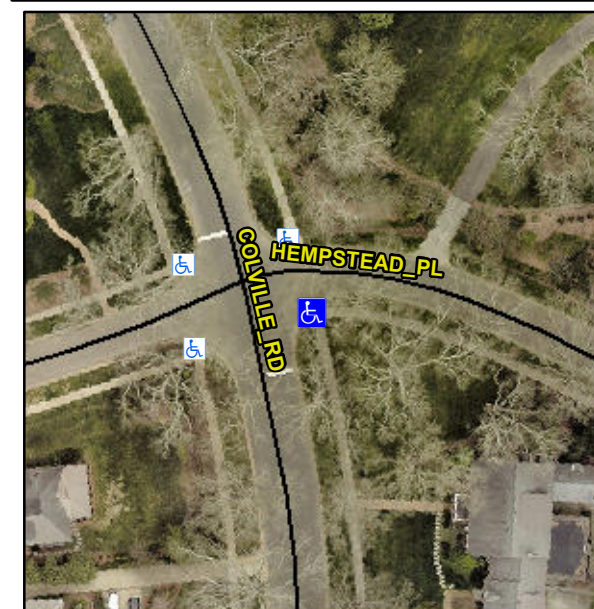
| ADA ID: 0F2271B1CB1E | Ramp Type: PerpDiag | Initial Pass/Fail: Fail | Overall Compliance: No |
| Severity Score: 1.25 | | | |

| Compliance | Description | Data | Compliance | Description | Data |
|---|---|---|---|---|---|
| Yes | Ramp Width (in) | 48.0 | No | Ramp XSlope (%) | 2.4 |

Remove & Replace Curb Ramp With Two New Directional Ramps or Equivalent.

R304.5.3

Total Cost: \$ 3200.00
