# Access Compliance Report

## Public Rights-of-Way

### (Curb Ramps)

Intersection ID: 10020376	Main Street: BALLANTYNE CORPORATE PCross Street: N/A	Location:	N
ADA ID: 0F29F3AAF273	Ramp Type: Perp	Initial Pass/Fail: Fail	Overall Compliance: No
		Severity Score:	25
Codes/Mitigation Info/Possible Solution		Field Measurements/Component Compliance

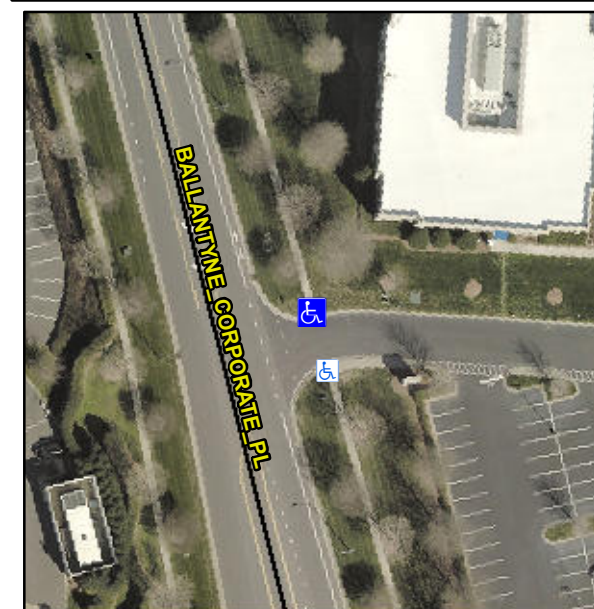
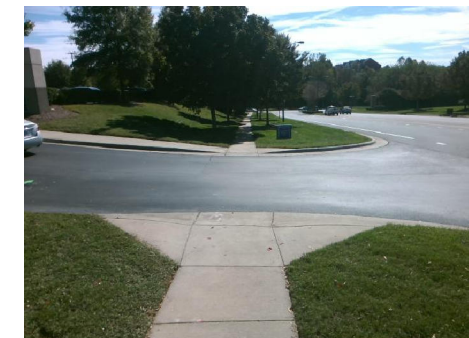
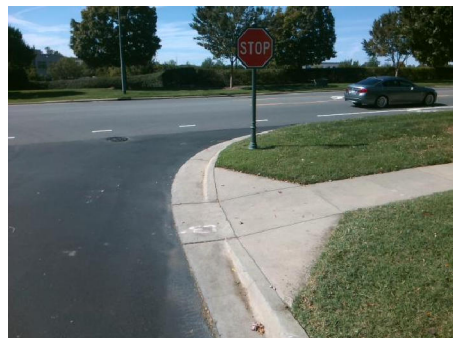
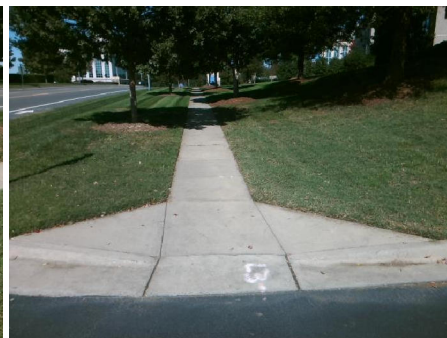
Compliance	Description	Data	Compliance	Description	Data
N/A	Ramp Length (in)	59.0	Yes	Ramp Slope (%)	6.3
Yes	Ramp Width (in)	48.0	No	Ramp XSlope (%)	9.9
N/A	Flare Type LT	N/A	N/A	Flare Type RT	N/A
N/A	Flare Slope LT (%)	N/A	N/A	Flare Slope RT (%)	N/A
N/A	Flare Traversable LT?	N/A	N/A	Flare Traversable RT?	N/A
N/A	Landing Length (in)	N/A	N/A	DWS Provided?	N/A
N/A	Landing Width (in)	N/A	N/A	DWS Contrast?	N/A
N/A	Landing Slope (%)	N/A	N/A	DWS Length (in)	N/A
N/A	Landing X Slope (%)	N/A	N/A	DWS Full Width?	N/A
N/A	Landing Curb? (Y/N)	N/A	N/A	DWS Offset (in)	N/A
N/A	Shared Landing?	N/A			
N/A	Gutter Ponding?	N/A	N/A	Gutter Slope (%)	N/A
N/A	Gutter Lip Ht (in)	N/A	N/A	Gutter X Slope (%)	N/A
N/A	Painted X Walk1?	No	N/A	Painted X Walk2?	N/A
	X Walk 1 Direction	To S		X Walk 2 Direction	N/A
N/A	X Walk 1 Width (in)	N/A	N/A	X Walk 2 Width (in)	N/A
	X Walk 1 Slope (%)	0.3		X Walk 2 Slope (%)	N/A
	X Walk 1 X Slope (%)	3.4		X Walk 2 X Slope (%)	N/A

N/A	Ramp inside XWalk1?	N/A	N/A	Ramp inside XWalk2?	N/A
	Road Slope (%)	N/A	N/A	Clear Space?	N/A
	Road X Slope (%)	N/A	N/A	Clear Space to XWalk (in)	N/A
N/A	Any Obstructions?	N/A	N/A	Storm Grate/Utility Hazard?	N/A
	Obstruction Type			Storm Grate/Utility Type	
		N/A			N/A
			Yes	Surface Condition? (G/P)	Good

Possible Solutions:

**Remove & Replace Entire Ramp.**

PROW/ADA:

**R304.5.3**
