Intersection ID: 11527	Main Street: BARRY_ST	Cross Street: GRACE_ST	Location:	NE
ADA ID: 0F2F7B0BE4A7	Ramp Type: PerpDiag	Initial Pass/Fail: Fail	Overall Compliance: No	Severity Score: 60

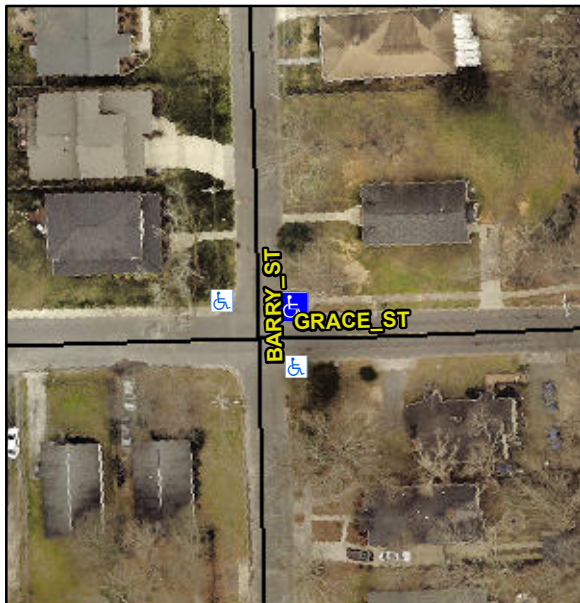
Possible Solutions:		Compliance	Description	Data	Compliance	Description	Data
	Remove & Replace Curb Ramp With Two New Directional Ramps or Equivalent.		N/A	Ramp Length (in)	52.0	No	Ramp Slope (%)	10.6
			No	Ramp Width (in)	26.0	No	Ramp XSlope (%)	6.8
			N/A	Flare Type LT	N/A	N/A	Flare Type RT	N/A
			N/A	Flare Slope LT (%)	N/A	N/A	Flare Slope RT (%)	N/A
			N/A	Flare Traversable LT?	N/A	N/A	Flare Traversable RT?	N/A
			N/A	Landing Length (in)	N/A	N/A	DWS Provided?	N/A
			N/A	Landing Width (in)	N/A	N/A	DWS Contrast?	N/A
			N/A	Landing Slope (%)	N/A	N/A	DWS Length (in)	N/A
			N/A	Landing X Slope (%)	N/A	N/A	DWS Full Width?	N/A
Street 1 Name	BARRY ST		N/A	Landing X Slope (%)	N/A	N/A	DWS Full Width?	N/A
	Stop Condition-Street 2		N/A	Landing Curb? (Y/N)	N/A	N/A	DWS Offset (in)	N/A
	Street 2 Name		N/A	Shared Landing?	N/A

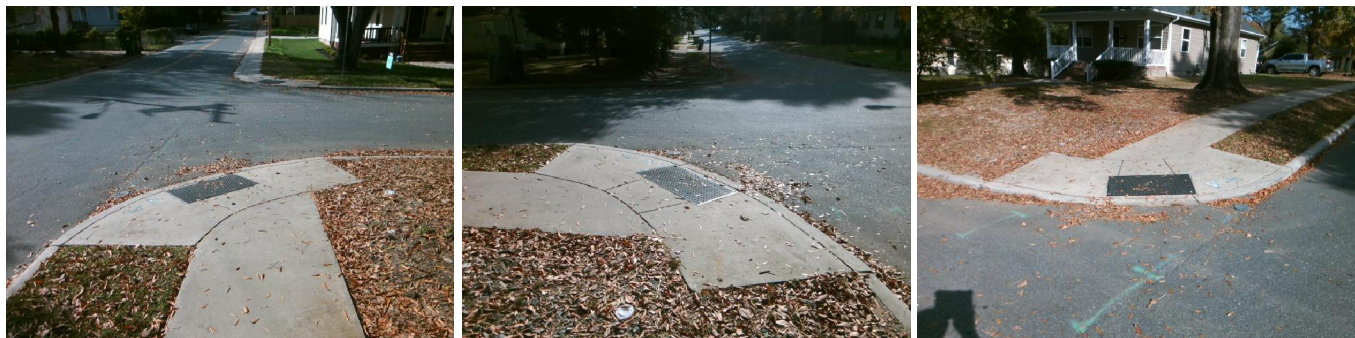
Stop Condition-Street 1		N/A	Gutter Ponding?	N/A	N/A	Gutter Slope (%)	N/A
			N/A	Gutter Lip Ht (in)	N/A	N/A	Gutter X Slope (%)	N/A
			N/A	Painted X Walk1?	No	N/A	Painted X Walk2?	No
				X Walk 1 Direction	To W		X Walk 2 Direction	To S
			N/A	X Walk 1 Width (in)	N/A	N/A	X Walk 2 Width (in)	N/A
				X Walk 1 Slope (%)	1.8		X Walk 2 Slope (%)	6.6
				X Walk 1 X Slope (%)	4.2		X Walk 2 X Slope (%)	3.3
PROW/ADA:		N/A	Ramp inside XWalk1?	N/A	N/A	Ramp inside XWalk2?	N/A	
Not Found, R304.5.1, R304.2.2, R304.5.3		N/A	Road Slope (%)	4.6	N/A	Clear Space?	N/A	
			Road X Slope (%)	1.1	N/A	Clear Space to XWalk (in)	N/A	
		N/A	Any Obstructions?	N/A	N/A	Storm Grate/Utility Hazard?	N/A	
			Obstruction Type			Storm Grate/Utility Type		
				N/A			N/A	
					Yes	Surface Condition? (G/P)	Good	
Total Cost:		\$ 3200.00
