Access Compliance Report

Public Rights-of-Way

(Curb Ramps)

Intersection ID: 46742	Main Street: HAMILTON_RD	Cross Street: CUMBERLAND_COVE_DR	Location: NW
ADA ID: 0F3703F37BBA	Ramp Type: PerpDiag	Initial Pass/Fail: Fail	Overall Compliance: No
		Severity Score: 8.75

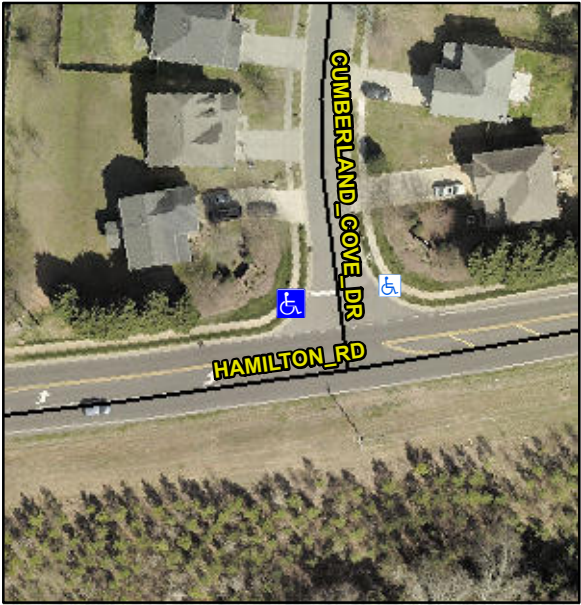
1.7	X Walk 1 Slope (%)	3.8
			4.2	X Walk 1 X Slope (%)	2.3
			N/A	Ramp inside XWalk1?	N/A
			0.7	Road Slope (%)	N/A
			4.0	Road X Slope (%)	N/A
			N/A	Any Obstructions?	N/A
			N/A	Obstruction Type	N/A
			N/A	Clear Space?	N/A
			N/A	Clear Space to XWalk (in)	N/A
			N/A	Storm Grate/Utility Hazard?	N/A
			N/A	Storm Grate/Utility Type	N/A
			Yes	Surface Condition? (G/P)	Good

<p>Street 1 Name CUMBERLAND COVE DR</p> <p>Stop Condition-Street 2 None</p> <p>Street 2 Name HAMILTON RD</p> <p>Stop Condition-Street 1 StopSign</p>	Possible Solutions:	Remove & Replace Curb Ramp With Two New Directional Ramps or Equivalent.			
	Surveyor Notes:	N/A			
	PROW/ADA:	R304.5.1			
	Total Cost:	\$ 3200.00			
			Compliance	Description	Data
			Yes	Ramp Slope (%)	7.2
			No	Ramp Width (in)	1.2
			N/A	Flare Type LT	N/A
			N/A	Flare Slope LT (%)	N/A
			N/A	Flare Traversable LT?	N/A
			N/A	Landing Length (in)	N/A
			N/A	Landing Width (in)	N/A
			N/A	Landing Slope (%)	N/A
			N/A	Landing X Slope (%)	N/A
			N/A	Landing Curb? (Y/N)	N/A
			N/A	Shared Landing?	N/A
			N/A	Gutter Ponding?	N/A
			N/A	Gutter Lip Ht (in)	N/A
			No	Painted X Walk1?	No
			To S	X Walk 1 Direction	To E
			N/A	X Walk 1 Width (in)	N/A
