Access Compliance Report

Public Rights-of-Way

(Curb Ramps)

Intersection ID: 11878		Main Street: MIMOSA_AV		Cross Street: THE_PLAZA		Location: NE							
ADA ID: 0F5242C12C94		Ramp Type: Directional1		Initial Pass/Fail: Fail		Overall Compliance: No		Severity Score: 12.5					
Codes/Mitigation Info/Possible Solution				Field Measurements/Component Compliance									
<div>

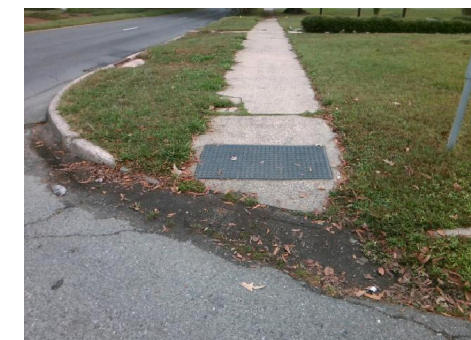
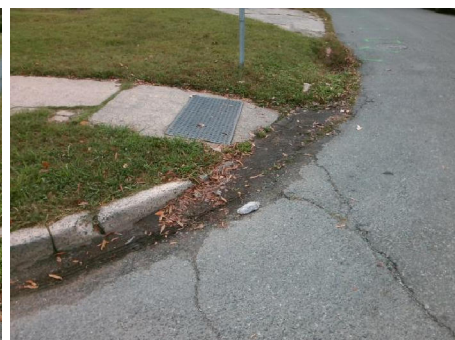
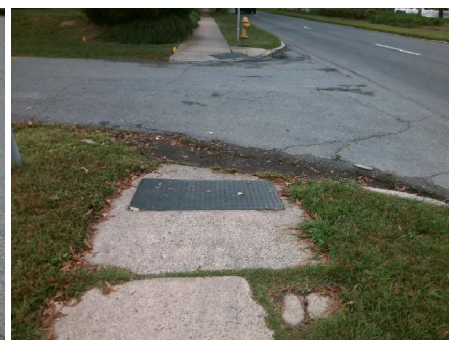
</div> <div>Possible Solutions:</div> <div>Remove & Replace Entire Ramp.</div> <div>Surveyor Notes:</div> <div>DAMAGED LNDG</div> <div>PROW/ADA:</div> <div>R304.2.2</div>				Compliance	Description	Data	Compliance	Description	Data				
				N/A	Ramp Length (in)	60.0	N/A	Grade Break?	N/A				
				Yes	Ramp Width (in)	65.0	N/A	Grade Break Slope (%)	0.0				
				No	Ramp Slope (%)	10.8	N/A	Grade Break XSlope (%)	0.0				
				Yes	Ramp XSlope (%)	2.0							
				N/A	Flare Type LT	N/A	N/A	Flare Type RT	N/A				
				N/A	Flare Slope LT (%)	N/A	N/A	Flare Slope RT (%)	0.0				
				N/A	Flare Traversable LT?	N/A	N/A	Flare Traversable RT?	N/A
