Access Compliance Report

Public Rights-of-Way

(Curb Ramps)

Intersection ID: N/A	Main Street: PERIWINKLE_HILL_CT	Cross Street: N/A	Location: S
ADA ID: 0F57728B186C	Ramp Type: Perp	Initial Pass/Fail: Pass	Overall Compliance: No
Severity Score: 0.25			
Codes/Mitigation Info/Possible Solution		Field Measurements/Component Compliance

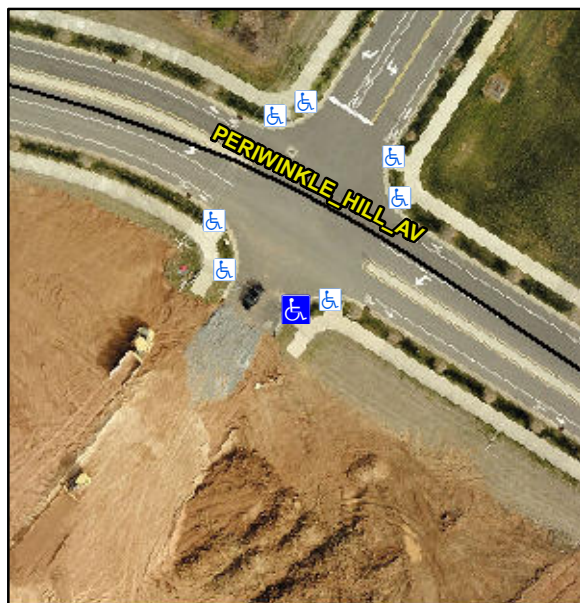
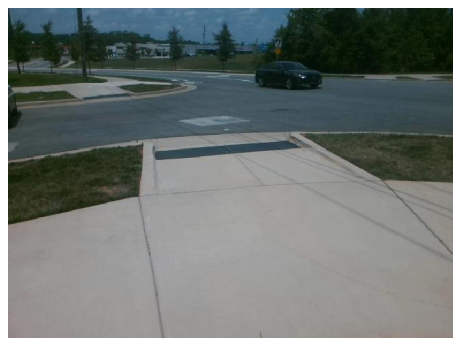
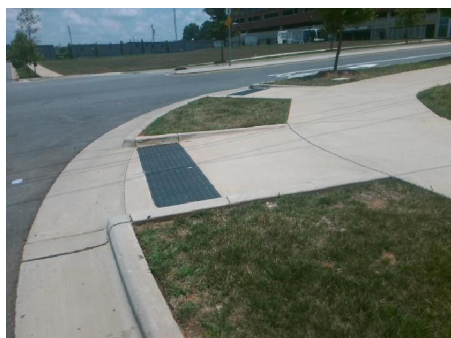
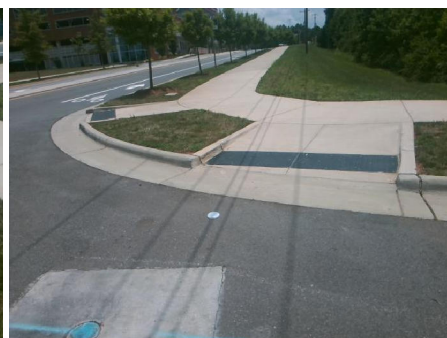
Compliance	Description	Data	Compliance	Description	Data
N/A	Ramp Length (in)	96.0	Yes	Ramp Slope (%)	5.4
Yes	Ramp Width (in)	91.0	No	Ramp XSlope (%)	2.3
Yes	Flare Type L	Curbed_NoWalkSurface	Yes	Flare Type RT	N/A
Yes	Flare Slope LT (%)	N/A	N/A	Flare Slope RT (%)	N/A
N/A	Flare Traversable LT?	No	N/A	Flare Traversable RT?	No
Yes	Landing Length (in)	97.0	Yes	DWS Provided?	Yes
Yes	Landing Width (in)	73.0	Yes	DWS Contrast?	Yes
No	Landing Slope (%)	2.2	Yes	DWS Length (in)	24.0
Yes	Landing X Slope (%)	1.2	Yes	DWS Full Width?	Yes
N/A	Landing Curb? (Y/N)	No	No	DWS Offset (in)	10.0
N/A	Shared Landing?	No			
Yes	Gutter Ponding?	No	Yes	Gutter Slope (%)	1.5
Yes	Gutter Lip Ht (in)	0.0	No	Gutter X Slope (%)	2.8
N/A	Painted X Walk1?	No	N/A	Painted X Walk2?	N/A
	X Walk 1 Direction	To NW		X Walk 2 Direction	N/A
N/A	X Walk 1 Width (in)	N/A	N/A	X Walk 2 Width (in)	N/A
	X Walk 1 Slope (%)	6.7		X Walk 2 Slope (%)	N/A
	X Walk 1 X Slope (%)	1.4		X Walk 2 X Slope (%)	N/A

N/A	Ramp inside XWalk1?	N/A	N/A	Ramp inside XWalk2?	N/A
	Road Slope (%)	N/A	N/A	Clear Space?	Yes
	Road X Slope (%)	N/A	N/A	Clear Space to XWalk (in)	N/A
Yes	Any Obstructions?	No	Yes	Storm Grate/Utility Hazard?	No
	Obstruction Type			Storm Grate/Utility Type	
		N/A			N/A
			Yes	Surface Condition? (G/P)	Good

Possible Solutions:

**Remove & Replace Entire Ramp.
Remove & Replace Gutter.**
