Access Compliance Report Public Rights-of-Way (Curb Ramps)

Intersection ID: 3979 Main Street: BROWNE'S FERRY RD Cross Street: YORKFORD DR Location: Ε ADA ID: 0F5CB3945283 Ramp Type: Perp Initial Pass/Fail: Fail **Overall Compliance: No Severity Score:** 60

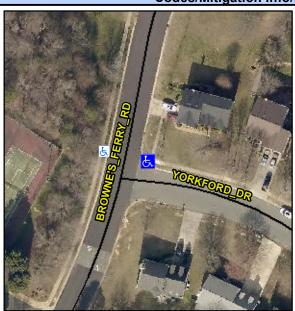
| Field Measurements/Component Compliance | | | | | | |
|---|---|---|---|---|---|---|
| | No | Ramp Width (in) | 31.5 | No | Ramp XSlope (%) | 8.3 |

Possible Solutions: Remove & Replace Entire Ramp. Surveyor Notes: N/A PROW/ADA: Not Found, R304.5.1, R304.5.3
