# Access Compliance Report

## Public Rights-of-Way

### (Curb Ramps)

Intersection ID: 45239	Main Street: BROOKWOOD_RD	Cross Street: CALDWELL_RD	Location: E
ADA ID: 0F6019A53F59	Ramp Type: Combination1	Initial Pass/Fail: Fail	Overall Compliance: No
Codes/Mitigation Info/Possible Solution		Field Measurements/Component Compliance	
Severity Score: 58.75

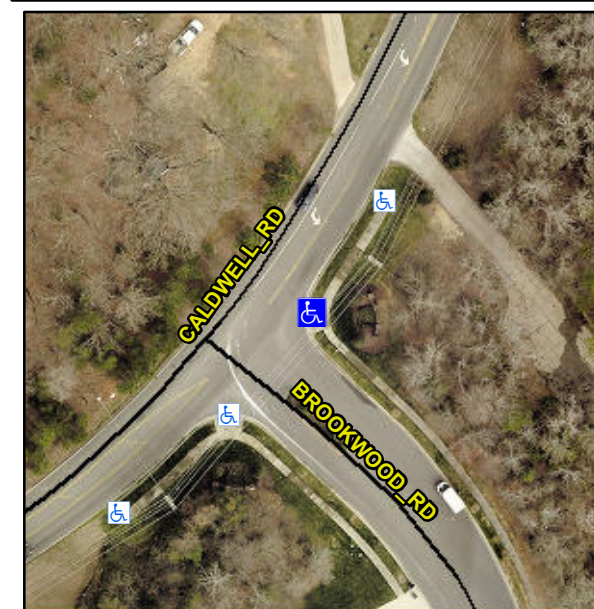
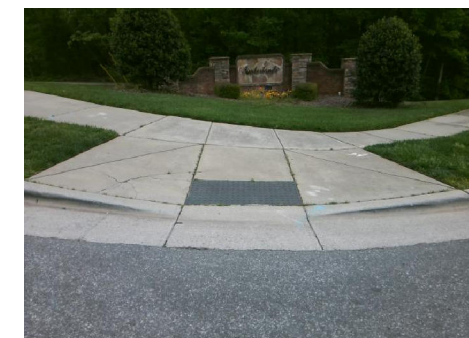
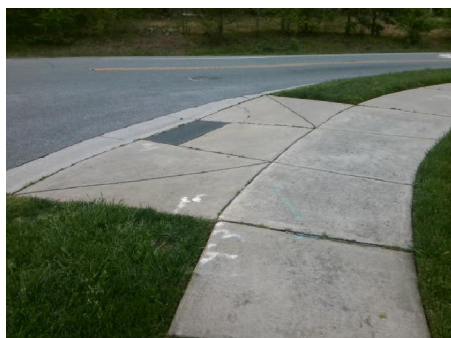
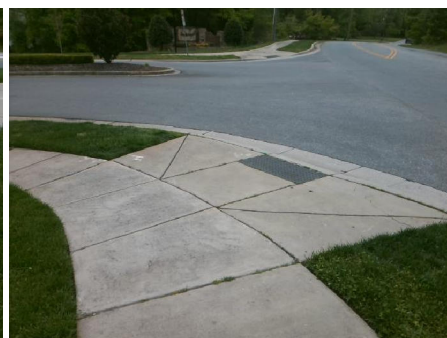
**CURB GAP 1.5**

**Not Found, R304.5.1, R304.5.3, R304.3.2**

Compliance	Description	Data	Compliance	Description	Data
N/A	Ramp Length LT (in)	34.5	N/A	Ramp Length RT (in)	35.0
Yes	Ramp Width LT (in)	55.0	Yes	Ramp Width RT (in)	51.0
No	Ramp Slope LT (%)	12.5	No	Ramp Slope RT (%)	10.0
No	Ramp XSlope LT (%)	3.4	Yes	Ramp XSlope RT (%)	0.2
N/A	Ramp Length (in)	76.0	Yes	Ramp Slope (%)	5.8
No	Ramp Width (in)	47.5	No	Ramp XSlope (%)	7.9
N/A	Flare Type LT	N/A	N/A	Flare Type RT	N/A
N/A	Flare Slope LT (%)	N/A	N/A	Flare Slope RT (%)	N/A
N/A	Flare Traversable LT?	N/A	N/A	Flare Traversable RT?	N/A
N/A	Landing Length (in)	N/A	N/A	DWS Provided?	N/A
N/A	Landing Width (in)	N/A	N/A	DWS Contrast?	N/A
N/A	Landing Slope (%)	N/A	N/A	DWS Length (in)	N/A
N/A	Landing X Slope (%)	N/A	N/A	DWS Full Width?	N/A
N/A	Landing Curb? (Y/N)	N/A	N/A	DWS Offset (in)	N/A
N/A	Shared Landing?	N/A			
N/A	Gutter Ponding?	N/A	N/A	Gutter Slope (%)	N/A
N/A	Gutter Lip Ht (in)	N/A	N/A	Gutter X Slope (%)	N/A
N/A	Painted X Walk1?	No	N/A	Painted X Walk2?	N/A

X Walk 1 Direction	To SW		X Walk 2 Direction	N/A
	X Walk 1 Width (in)	N/A		X Walk 2 Width (in)	N/A
	X Walk 1 Slope (%)	0.6		X Walk 2 Slope (%)	N/A
	X Walk 1 X Slope (%)	7.3		X Walk 2 X Slope (%)	N/A
N/A	Ramp inside XWalk1?	N/A	N/A	Ramp inside XWalk2?	N/A
	Road Slope (%)	N/A		Clear Space?	N/A
	Road X Slope (%)	N/A	N/A	Clear Space to XWalk (in)	N/A
			N/A	Any Obstruction?	N/A
				Obstruction Type	N/A
			N/A	Storm Grate/Utility Hazard?	N/A
				Storm Grate/Utility Type	N/A
			Yes	Surface Condition? (G/P)	Good
				Curb Slope (%)	24.1

Possible Solutions:

**Remove & Replace Entire Ramp.**
