# Access Compliance Report

## Public Rights-of-Way

### (Curb Ramps)

Intersection ID: 14071	Main Street: CLEVELAND_AV	Cross Street: E_KINGSTON_AV	Location: W
ADA ID: 0F71D223DB02	Ramp Type: Perp	Initial Pass/Fail: Fail	Overall Compliance: No
Severity Score: 22.5			
Codes/Mitigation Info/Possible Solution		Field Measurements/Component Compliance

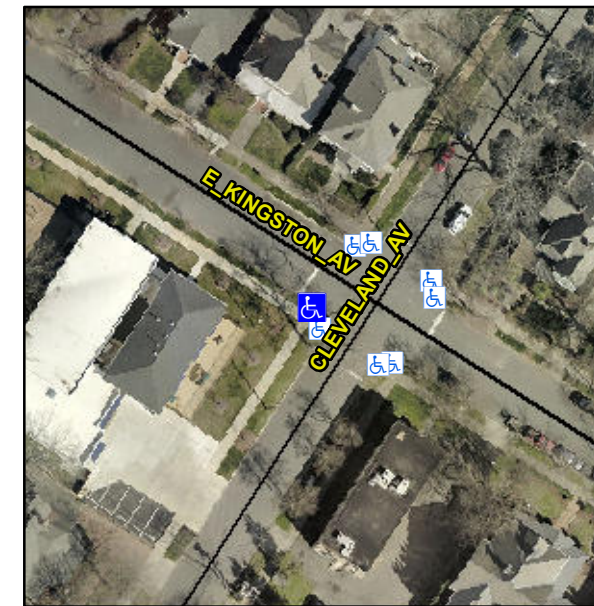
Compliance	Description	Data	Compliance	Description	Data
N/A	Ramp Length (in)	53.0	No	Ramp Slope (%)	8.4
No	Ramp Width (in)	36.0	No	Ramp XSlope (%)	3.4
N/A	Flare Type LT	N/A	N/A	Flare Type RT	N/A
N/A	Flare Slope LT (%)	N/A	N/A	Flare Slope RT (%)	N/A
N/A	Flare Traversable LT?	N/A	N/A	Flare Traversable RT?	N/A
N/A	Landing Length (in)	N/A	N/A	DWS Provided?	N/A
N/A	Landing Width (in)	N/A	N/A	DWS Contrast?	N/A
N/A	Landing Slope (%)	N/A	N/A	DWS Length (in)	N/A
N/A	Landing X Slope (%)	N/A	N/A	DWS Full Width?	N/A
N/A	Landing Curb? (Y/N)	N/A	N/A	DWS Offset (in)	N/A
N/A	Shared Landing?	N/A			
N/A	Gutter Ponding?	N/A	N/A	Gutter Slope (%)	N/A
N/A	Gutter Lip Ht (in)	N/A	N/A	Gutter X Slope (%)	N/A
N/A	Painted X Walk1?	No	N/A	Painted X Walk2?	N/A
	X Walk 1 Direction	To NE		X Walk 2 Direction	N/A
N/A	X Walk 1 Width (in)	N/A	N/A	X Walk 2 Width (in)	N/A
	X Walk 1 Slope (%)	2.5		X Walk 2 Slope (%)	N/A
	X Walk 1 X Slope (%)	1.1		X Walk 2 X Slope (%)	N/A

N/A	Ramp inside XWalk1?	N/A	N/A	Ramp inside XWalk2?	N/A
	Road Slope (%)	N/A	N/A	Clear Space?	N/A
	Road X Slope (%)	N/A	N/A	Clear Space to XWalk (in)	N/A
N/A	Any Obstructions?	N/A	N/A	Storm Grate/Utility Hazard?	N/A
	Obstruction Type			Storm Grate/Utility Type	
		N/A			N/A
			Yes	Surface Condition? (G/P)	Good

Possible Solutions:

**Remove & Replace Entire Ramp.**
