Access Compliance Report

Public Rights-of-Way

(Curb Ramps)

Intersection ID: 9907	Main Street: RUTH_DR	Cross Street: SHANNONHOUSE_DR	Location: W
ADA ID: 0F8076F220C2	Ramp Type: Perp	Initial Pass/Fail: Fail	Overall Compliance: No
		Severity Score: 12.5

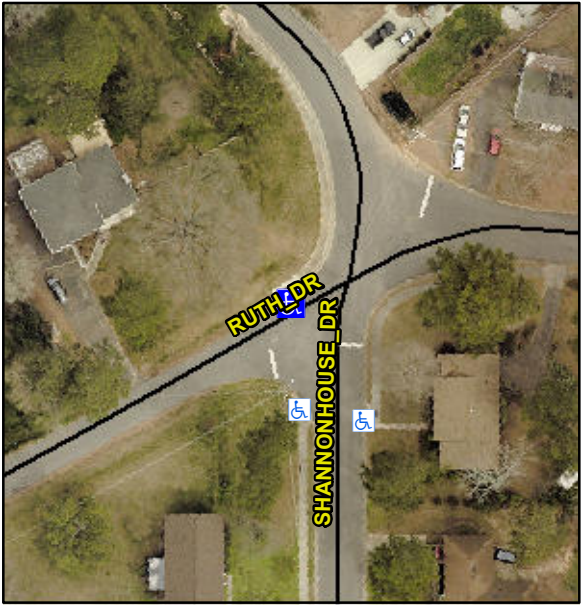
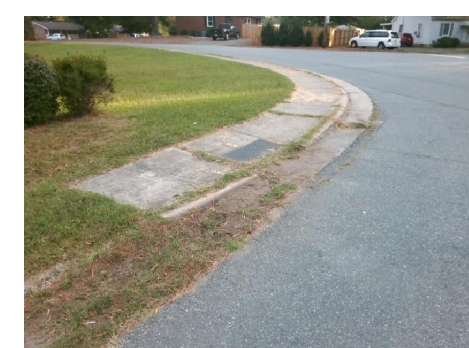
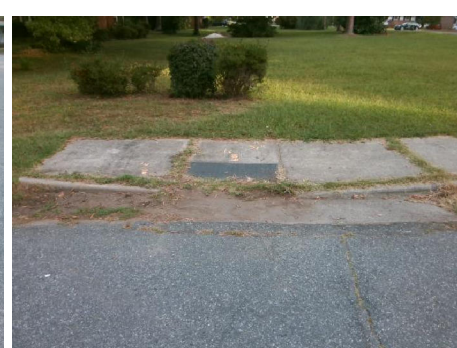
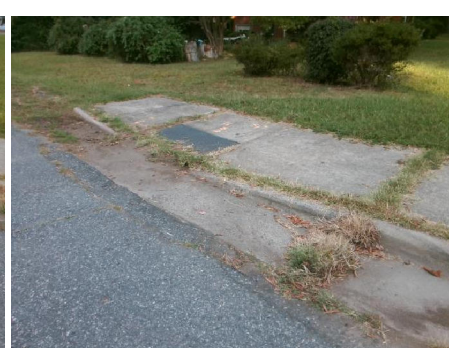
Possible Solutions:		Compliance	Description	Data
	Remove & Replace Entire Ramp.		No	Ramp Slope (%)	10.9
			Yes	Ramp Width (in)	1.6
			N/A	Flare Type LT	N/A
			N/A	Flare Slope LT (%)	N/A
			N/A	Flare Traversable LT?	N/A
			N/A	Landing Length (in)	N/A
			N/A	Landing Width (in)	N/A
			N/A	Landing Slope (%)	N/A
			N/A	Landing X Slope (%)	N/A
<p>Surveyor Notes:</p> <p>N/A</p> <p>PROW/ADA:</p> <p>Not Found, R304.2.2</p>			N/A	Flare Type RT	N/A
			N/A	Flare Slope RT (%)	N/A
			N/A	Flare Traversable RT?	N/A
			N/A	DWS Provided?	N/A
			N/A	DWS Contrast?	N/A
			N/A	DWS Length (in)	N/A
			N/A	DWS Full Width?	N/A
			N/A	DWS Offset (in)	N/A
			N/A	Shared Landing?	N/A
			N/A	Gutter Ponding?	N/A
			Yes	Gutter Slope (%)	N/A

1.0	Gutter X Slope (%)	N/A
			No	Painted X Walk2?	N/A
			To S	X Walk 2 Direction	N/A
			N/A	X Walk 2 Width (in)	N/A
			0.6	X Walk 2 Slope (%)	N/A
			1.4	X Walk 2 X Slope (%)	N/A
			N/A	Ramp inside XWalk2?	N/A
			N/A	Clear Space?	N/A
			N/A	Clear Space to XWalk (in)	N/A
			N/A	Storm Grate/Utility Hazard?	N/A
			N/A	Storm Grate/Utility Type	N/A
			N/A		N/A
			Yes	Surface Condition? (G/P)	Good
Total Cost:		\$ 1850.00
