Access Compliance Report Public Rights-of-Way (Curb Ramps)

Intersection ID: N/A Main Street: ORCHID_BRDIGE_RD Cross Street: N/A Location: S

ADA ID: 0F8A17F6FFD2 Ramp Type: Perp Initial Pass/Fail: Fail Overall Compliance: No Severity Score: 12.5

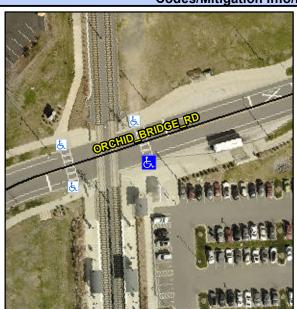
Comp	oliance Description		ponent Compliance ompliance Description Data		
N/A	Ramp Length (in)	<u>Data</u> 98.0	No	Ramp Slope (%)	8.7
Yes	Ramp Width (in)	48.0	Yes	Ramp XSlope (%)	0.6
N/A	Flare Type LT	N/A	N/A	Flare Type RT	N/A
N/A	Flare Slope LT (%)	N/A	N/A	Flare Slope RT (%)	N/A
N/A	Flare Traversable LT?	N/A	N/A	Flare Traversable RT?	N/A
N/A	Landing Length (in)	N/A	N/A	DWS Provided?	N/A
N/A	Landing Width (in)	N/A	N/A	DWS Contrast?	N/A
N/A	Landing Slope (%)	N/A	N/A	DWS Length (in)	N/A
N/A	Landing X Slope (%)	N/A	N/A	DWS Full Width?	N/A
N/A	Landing Curb? (Y/N)	N/A	N/A	DWS Offset (in)	N/A
N/A	Shared Landing?	N/A			
N/A	Gutter Ponding?	N/A	N/A	Gutter Slope (%)	N/A
N/A	Gutter Lip Ht (in)	N/A	N/A	Gutter X Slope (%)	N/A
N/A	Painted X Walk1?	Yes	N/A	Painted X Walk2?	N/A
	X Walk 1 Direction	To N		X Walk 2 Direction	N/A
N/A	X Walk 1 Width (in)	104.0	N/A	X Walk 2 Width (in)	N/A
	X Walk 1 Slope (%)	1.4		X Walk 2 Slope (%)	N/A

X Walk 1 X Slope (%)	1.8		X Walk 2 X Slope (%)	N/A
N/A	Ramp inside XWalk1?	Yes	N/A	Ramp inside XWalk2?	N/A
	Road Slope (%)	N/A	N/A	Clear Space?	N/A
	Road X Slope (%)	N/A	N/A	Clear Space to XWalk (in)	N/A
N/A	Any Obstructions?	N/A	N/A	Storm Grate/Utility Hazard?	N/A
	Obstruction Type			Storm Grate/Utility Type	
		N/A			N/A
			Yes	Surface Condition? (G/P)	Good
	THE RESERVE AND ADDRESS OF THE PERSON OF THE

No. of	Possible Solutions:
The second second	Remove & Replace Entire Ramp.
é	Surveyor Notes:
	N/A
	PROW/ADA:
	R304.2.2

Total Cost:	\$	1850.0
		SOLANIA
