Access Compliance Report Public Rights-of-Way (Curb Ramps)

Intersection ID: 16186	Main Street: POINDEXTER_DR	Cross Street: WINDSOR_AV	Location: N
ADA ID: 0F8BB985C5E2	Ramp Type: BlendTrans2	Initial Pass/Fail: Fail	Overall Compliance: No
Codes/Mitigation Info/Possible Solution			Field Measurements/Component Compliance

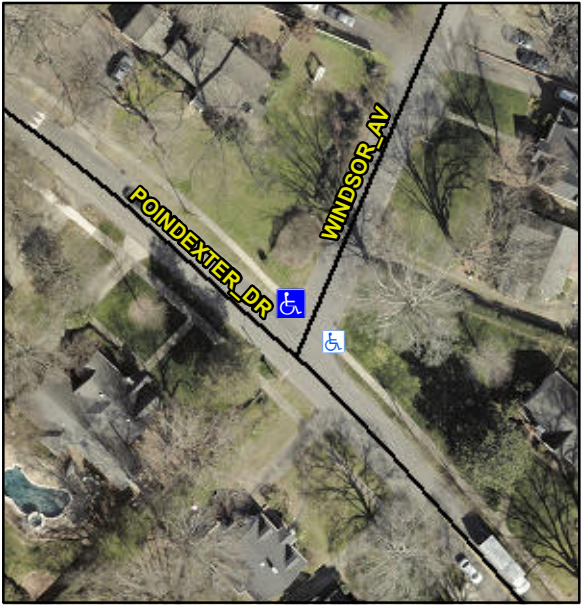
PROW/ADA:
Not Found, R304.5.3

Compliance	Description	Data	Compliance	Description	Data
N/A	Ramp Length (in)	45.0	Yes	BlendTrans Slope (%)	0.5
Yes	Ramp Width (in)	48.0	No	BlendTrans XSlope (%)	3.5
N/A	Flare Type LT	N/A	N/A	Flare Type RT	N/A
N/A	Flare Slope LT (%)	N/A	N/A	Flare Slope RT (%)	N/A
N/A	Flare Traversable LT?	N/A	N/A	Flare Traversable RT?	N/A
N/A	Landing Length (in)	N/A	N/A	DWS Provided?	N/A
N/A	Landing Width (in)	N/A	N/A	DWS Contrast?	N/A
N/A	Landing Slope (%)	N/A	N/A	DWS Length (in)	N/A
N/A	Landing X Slope (%)	N/A	N/A	DWS Full Width?	N/A
N/A	Landing Curb? (Y/N)	N/A	N/A	DWS Offset (in)	N/A
N/A	Shared Landing?	N/A			
N/A	Gutter Ponding?	N/A	N/A	Gutter Slope (%)	N/A
N/A	Gutter Lip Ht (in)	N/A	N/A	Gutter X Slope (%)	N/A
N/A	Painted X Walk1?	No	N/A	Painted X Walk2?	N/A
	X Walk 1 Direction	To SE		X Walk 2 Direction	N/A
	X Walk 1 Width (in)	N/A		X Walk 2 Width (in)	N/A
	X Walk 1 Slope (%)	1.0		X Walk 2 Slope (%)	N/A
	X Walk 1 X Slope (%)	3.5		X Walk 2 X Slope (%)	N/A

N/A	Ramp inside XWalk1?	N/A	N/A	Ramp inside XWalk2?	N/A
	Road Slope (%)	3.5		Clear Space?	N/A
	Road X Slope (%)	1.0	N/A	Clear Space to XWalk (in)	N/A
N/A	Any Obstructions?	N/A	N/A	Storm Grate/Utility Hazard?	N/A
	Obstruction Type			Storm Grate/Utility Type	
		N/A			N/A
Yes	Surface Condition? (G/P)		Yes		Good
No	Curb Slope (%)		No		6.5

Possible Solutions:
Remove & Replace Curb Ramp With Two New Directional Ramps or Equivalent.

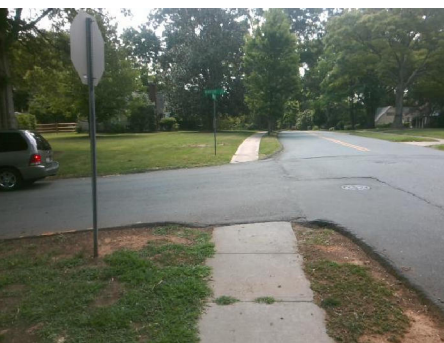
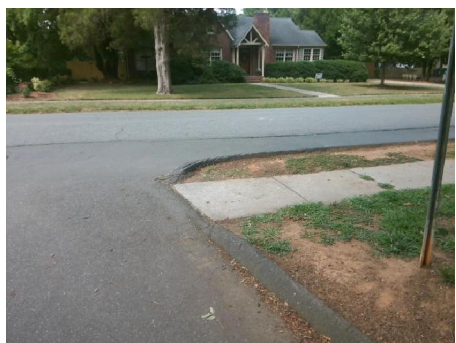
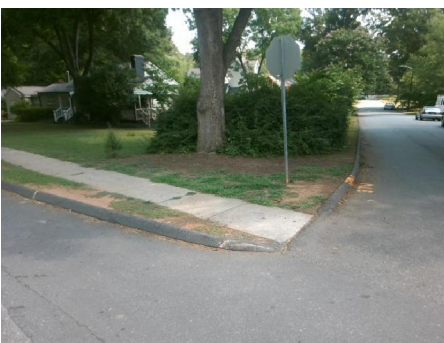
Surveyor Notes:
ASP CURB
