Access Compliance Report Public Rights-of-Way (Curb Ramps)

Intersection ID: N/A Main Street: E_MARTIN_LUTHER_KING_JR_GPVss Street: S_CALDWELL_ST Location: SW

ADA ID: 0F9090E5CAC0 Ramp Type: Perp Initial Pass/Fail: Pass Overall Compliance: No Severity Score: 7.75

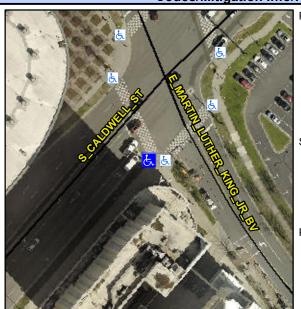
Not Found, R304.2.2-Perp, R304.3.2-Para, R305.2, R302.7.2, R304.5.3

Field Measurements/Component Compliance						
Compliance Description			Data	Data Compliance Description		
N	I/A	Ramp Length (in)	95.5	Yes	Ramp Slope (%)	8.0
Υ	'es	Ramp Width (in)	48.0	Yes	Ramp XSlope (%)	3.4
N	l/A	Flare Type LT	Sloped	N/A	Flare Type RT	N/A
N	I/A	Flare Slope LT (%)	3.7	N/A	Flare Slope RT (%)	9.3
N	I/A	Flare Traversable LT?	Yes	N/A	Flare Traversable RT?	No
Υ	'es	Landing Length (in)	60.0	Yes	DWS Provided?	Yes
Υ	'es	Landing Width (in)	48.0	Yes	DWS Contrast?	Yes
N	lo	Landing Slope (%)	3.2	Yes	DWS Length (in)	24.0
Υ	'es	Landing X Slope (%)	2.4	Yes	DWS Full Width?	Yes
N	I/A	Landing Curb? (Y/N)	No	No	DWS Offset (in)	6.5
N	I/A	Shared Landing?	No			
Υ	'es	Gutter Ponding?	No	Yes	Gutter Slope (%)	2.6
N	lo	Gutter Lip Ht (in)	0.5	No	Gutter X Slope (%)	4.4
N	I/A	Painted X Walk1?	Yes	N/A	Painted X Walk2?	N/A
		X Walk 1 Direction	To N		X Walk 2 Direction	N/A
N	I/A	X Walk 1 Width (in)	144.0	N/A	X Walk 2 Width (in)	N/A

X Walk 1 Slope (%)	3.0		X Walk 2 Slope (%)	N/A
		X Walk 1 X Slope (%)	3.9		X Walk 2 X Slope (%)	N/A
Υ	'es	Ramp inside XWalk1?	Yes	N/A	Ramp inside XWalk2?	N/A
		Road Slope (%)	N/A	N/A	Clear Space?	Yes
		Road X Slope (%)	N/A	N/A	Clear Space to XWalk (in)	N/A
Υ	'es	Any Obstructions?	No	Yes	Storm Grate/Utility Hazard?	No
		Obstruction Type			Storm Grate/Utility Type	
			N/A			N/A

Remove & Replace Entire Ramp.
Remove & Replace Gutter.

Total Cost: \$ 2600.00
