Access Compliance Report

Public Rights-of-Way

(Curb Ramps)

Intersection ID: 15956	Main Street: POINDEXTER_DR	Cross Street: SEDGEFIELD_RD	Location: S
ADA ID: 0F912306F571	Ramp Type: PerpDiag	Initial Pass/Fail: Fail	Overall Compliance: No
		Severity Score: 1.25

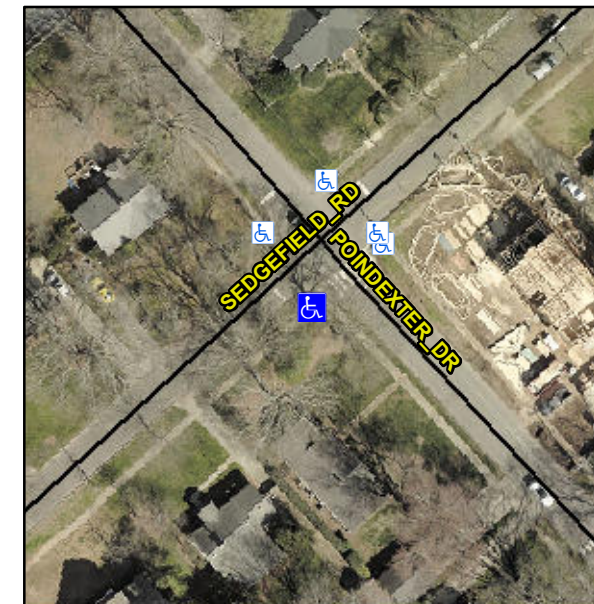
Compliance	Description	Data	Compliance	Description	Data
N/A	Ramp Length (in)	83.0	Yes	Ramp Slope (%)	5.1
Yes	Ramp Width (in)	48.0	No	Ramp XSlope (%)	2.2
N/A	Flare Type LT	N/A	N/A	Flare Type RT	N/A
N/A	Flare Slope LT (%)	N/A	N/A	Flare Slope RT (%)	N/A
N/A	Flare Traversable LT?	N/A	N/A	Flare Traversable RT?	N/A
N/A	Landing Length (in)	N/A	N/A	DWS Provided?	N/A
N/A	Landing Width (in)	N/A	N/A	DWS Contrast?	N/A
N/A	Landing Slope (%)	N/A	N/A	DWS Length (in)	N/A
N/A	Landing X Slope (%)	N/A	N/A	DWS Full Width?	N/A
N/A	Landing Curb? (Y/N)	N/A	N/A	DWS Offset (in)	N/A
N/A	Shared Landing?	N/A			
N/A	Gutter Ponding?	N/A	N/A	Gutter Slope (%)	N/A
N/A	Gutter Lip Ht (in)	N/A	N/A	Gutter X Slope (%)	N/A
N/A	Painted X Walk1?	Yes	N/A	Painted X Walk2?	No
	X Walk 1 Direction	To NE		X Walk 2 Direction	To NW
N/A	X Walk 1 Width (in)	113.0	N/A	X Walk 2 Width (in)	N/A
	X Walk 1 Slope (%)	3.3		X Walk 2 Slope (%)	2.9
	X Walk 1 X Slope (%)	2.8		X Walk 2 X Slope (%)	0.6

N/A	Ramp inside XWalk1?	Yes	N/A	Ramp inside XWalk2?	N/A
	Road Slope (%)	2.9	N/A	Clear Space?	N/A
	Road X Slope (%)	4.0	N/A	Clear Space to XWalk (in)	N/A
N/A	Any Obstructions?	N/A	N/A	Storm Grate/Utility Hazard?	N/A
	Obstruction Type			Storm Grate/Utility Type	
		N/A			N/A
		Yes		Surface Condition? (G/P)	Good

Remove & Replace Curb Ramp With Two New Directional Ramps or Equivalent.

R304.5.3

\$ 3200.00
