Intersection ID: 5840	Main Street: DELLINGER_CR	Cross Street: MILHAVEN_LN	Location:	SW
ADA ID: 0F970056A455	Ramp Type: BlendTrans1	Initial Pass/Fail: Fail	Overall Compliance: No	Severity Score: 1.25

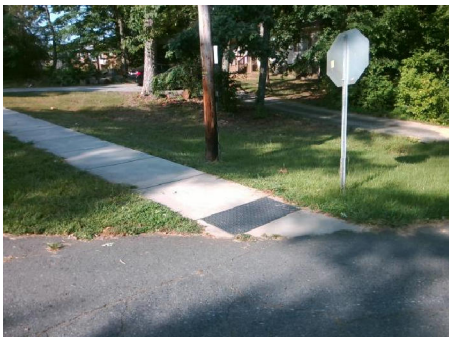
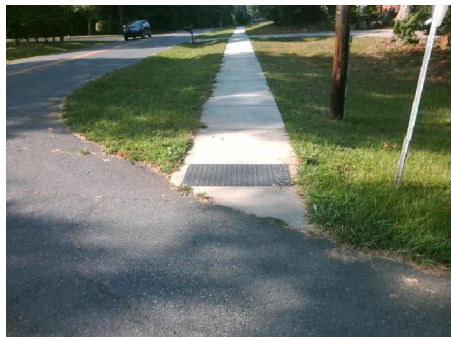
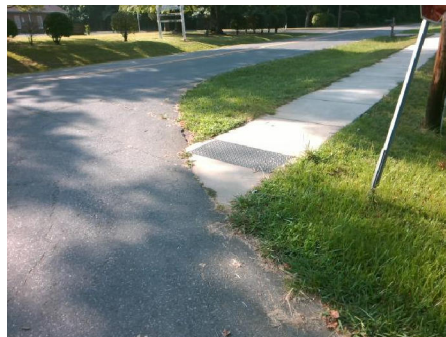
NO CURB, DWS OS MEASURED TO ASPHALT

Compliance	Description	Data	Compliance	Description	Data
N/A	Ramp Length (in)	23.0	Yes	BlendTrans Slope (%)	3.9
Yes	Ramp Width (in)	60.0	No	BlendTrans XSlope (%)	3.5
N/A	Flare Type LT	N/A	N/A	Flare Type RT	N/A
N/A	Flare Slope LT (%)	N/A	N/A	Flare Slope RT (%)	N/A
N/A	Flare Traversable LT?	N/A	N/A	Flare Traversable RT?	N/A
N/A	Landing Length (in)	N/A	N/A	DWS Provided?	N/A
N/A	Landing Width (in)	N/A	N/A	DWS Contrast?	N/A
N/A	Landing Slope (%)	N/A	N/A	DWS Length (in)	N/A
N/A	Landing X Slope (%)	N/A	N/A	DWS Full Width?	N/A
N/A	Landing Curb? (Y/N)	N/A	N/A	DWS Offset (in)	N/A
N/A	Shared Landing?	N/A			
N/A	Gutter Ponding?	N/A	N/A	Gutter Slope (%)	N/A
N/A	Gutter Lip Ht (in)	N/A	N/A	Gutter X Slope (%)	N/A
N/A	Painted X Walk1?	No	N/A	Painted X Walk2?	N/A
	X Walk 1 Direction	To N		X Walk 2 Direction	N/A
	X Walk 1 Width (in)	N/A		X Walk 2 Width (in)	N/A
	X Walk 1 Slope (%)	1.8		X Walk 2 Slope (%)	N/A
	X Walk 1 X Slope (%)	5.3		X Walk 2 X Slope (%)	N/A

N/A	Ramp inside XWalk1?	N/A	N/A	Ramp inside XWalk2?	N/A
	Road Slope (%)	5.3		Clear Space?	N/A
	Road X Slope (%)	1.8	N/A	Clear Space to XWalk (in)	N/A
N/A	Any Obstructions?	N/A	N/A	Storm Grate/Utility Hazard?	N/A
	Obstruction Type			Storm Grate/Utility Type	
		N/A			N/A
			Yes	Surface Condition? (G/P)	Good
			N/A	Curb Slope (%)	N/A

Remove & Replace Curb Ramp With Two New Directional Ramps or Equivalent.
