Access Compliance Report

Public Rights-of-Way

(Curb Ramps)

Intersection ID: 3738	Main Street: SANDRINGHAM_PL	Cross Street: WITHERSHINN_DR	Location: NE
ADA ID: 0F98AD2AFD2E	Ramp Type: Perp	Initial Pass/Fail: Fail	Overall Compliance: No
Severity Score: 1.25			
Codes/Mitigation Info/Possible Solution		Field Measurements/Component Compliance

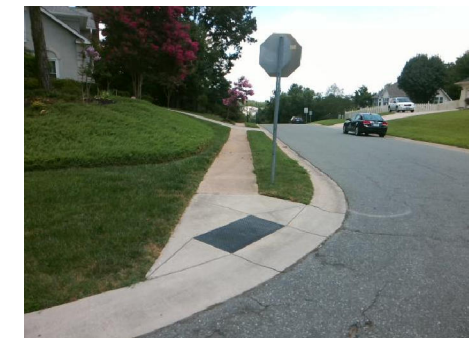
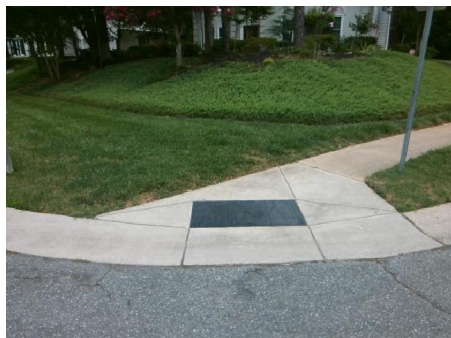
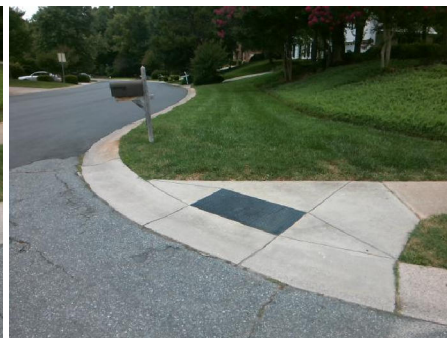
Compliance	Description	Data	Compliance	Description	Data
N/A	Ramp Length (in)	40.0	Yes	Ramp Slope (%)	6.6
Yes	Ramp Width (in)	48.0	No	Ramp XSlope (%)	2.2
N/A	Flare Type LT	N/A	N/A	Flare Type RT	N/A
N/A	Flare Slope LT (%)	N/A	N/A	Flare Slope RT (%)	N/A
N/A	Flare Traversable LT?	N/A	N/A	Flare Traversable RT?	N/A
N/A	Landing Length (in)	N/A	N/A	DWS Provided?	N/A
N/A	Landing Width (in)	N/A	N/A	DWS Contrast?	N/A
N/A	Landing Slope (%)	N/A	N/A	DWS Length (in)	N/A
N/A	Landing X Slope (%)	N/A	N/A	DWS Full Width?	N/A
N/A	Landing Curb? (Y/N)	N/A	N/A	DWS Offset (in)	N/A
N/A	Shared Landing?	N/A			
N/A	Gutter Ponding?	N/A	N/A	Gutter Slope (%)	N/A
N/A	Gutter Lip Ht (in)	N/A	N/A	Gutter X Slope (%)	N/A
N/A	Painted X Walk1?	No	N/A	Painted X Walk2?	N/A
	X Walk 1 Direction	To S		X Walk 2 Direction	N/A
N/A	X Walk 1 Width (in)	N/A	N/A	X Walk 2 Width (in)	N/A
	X Walk 1 Slope (%)	2.2		X Walk 2 Slope (%)	N/A
	X Walk 1 X Slope (%)	0.1		X Walk 2 X Slope (%)	N/A

N/A	Ramp inside XWalk1?	N/A	N/A	Ramp inside XWalk2?	N/A
	Road Slope (%)	N/A	N/A	Clear Space?	N/A
	Road X Slope (%)	N/A	N/A	Clear Space to XWalk (in)	N/A
N/A	Any Obstructions?	N/A	N/A	Storm Grate/Utility Hazard?	N/A
	Obstruction Type			Storm Grate/Utility Type	
		N/A			N/A
			Yes	Surface Condition? (G/P)	Good

Remove & Replace Entire Ramp.
