Access Compliance Report

Public Rights-of-Way

(Curb Ramps)

Intersection ID: 15247	Main Street: E_INDEPENDENCE_BV	Cross Street: EASTWAY_DR_RA	Location: NE
ADA ID: 0FB25F4C29F5	Ramp Type: Perp	Initial Pass/Fail: Fail	Overall Compliance: No
Codes/Mitigation Info/Possible Solution			Severity Score: 10
			Field Measurements/Component Compliance

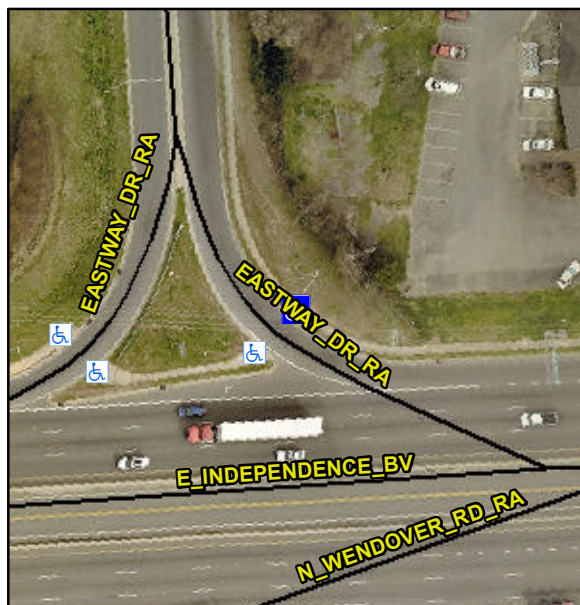
Not Found, R304.5.1, R304.5.3

Compliance	Description	Data	Compliance	Description	Data
N/A	Ramp Length (in)	88.0	Yes	Ramp Slope (%)	6.1
No	Ramp Width (in)	47.0	No	Ramp XSlope (%)	2.5
N/A	Flare Type LT	N/A	N/A	Flare Type RT	N/A
N/A	Flare Slope LT (%)	N/A	N/A	Flare Slope RT (%)	N/A
N/A	Flare Traversable LT?	N/A	N/A	Flare Traversable RT?	N/A
N/A	Landing Length (in)	N/A	N/A	DWS Provided?	N/A
N/A	Landing Width (in)	N/A	N/A	DWS Contrast?	N/A
N/A	Landing Slope (%)	N/A	N/A	DWS Length (in)	N/A
N/A	Landing X Slope (%)	N/A	N/A	DWS Full Width?	N/A
N/A	Landing Curb? (Y/N)	N/A	N/A	DWS Offset (in)	N/A
N/A	Shared Landing?	N/A			
N/A	Gutter Ponding?	N/A	N/A	Gutter Slope (%)	N/A
N/A	Gutter Lip Ht (in)	N/A	N/A	Gutter X Slope (%)	N/A
N/A	Painted X Walk1?	No	N/A	Painted X Walk2?	N/A
	X Walk 1 Direction	To SW		X Walk 2 Direction	N/A
N/A	X Walk 1 Width (in)	N/A	N/A	X Walk 2 Width (in)	N/A
	X Walk 1 Slope (%)	5.4		X Walk 2 Slope (%)	N/A
	X Walk 1 X Slope (%)	1.9		X Walk 2 X Slope (%)	N/A

N/A	Ramp inside XWalk1?	N/A	N/A	Ramp inside XWalk2?	N/A
	Road Slope (%)	N/A	N/A	Clear Space?	N/A
	Road X Slope (%)	N/A	N/A	Clear Space to XWalk (in)	N/A
N/A	Any Obstructions?	N/A	N/A	Storm Grate/Utility Hazard?	N/A
	Obstruction Type			Storm Grate/Utility Type	
		N/A			N/A
			Yes	Surface Condition? (G/P)	Good

Remove & Replace Entire Ramp.
